# **SURVEY REPORT FOR ASBESTOS AND LEAD-BASED PAINT**

**DELIVERY ORDER No. 0027  
INTERIOR/EXTERIOR REPAIRS, BLDG. M101  
MARINE CORPS BASE – CAMP JOHNSON  
JACKSONVILLE, NORTH CAROLINA**

**ISSUE DATE: JUNE 5, 2019**

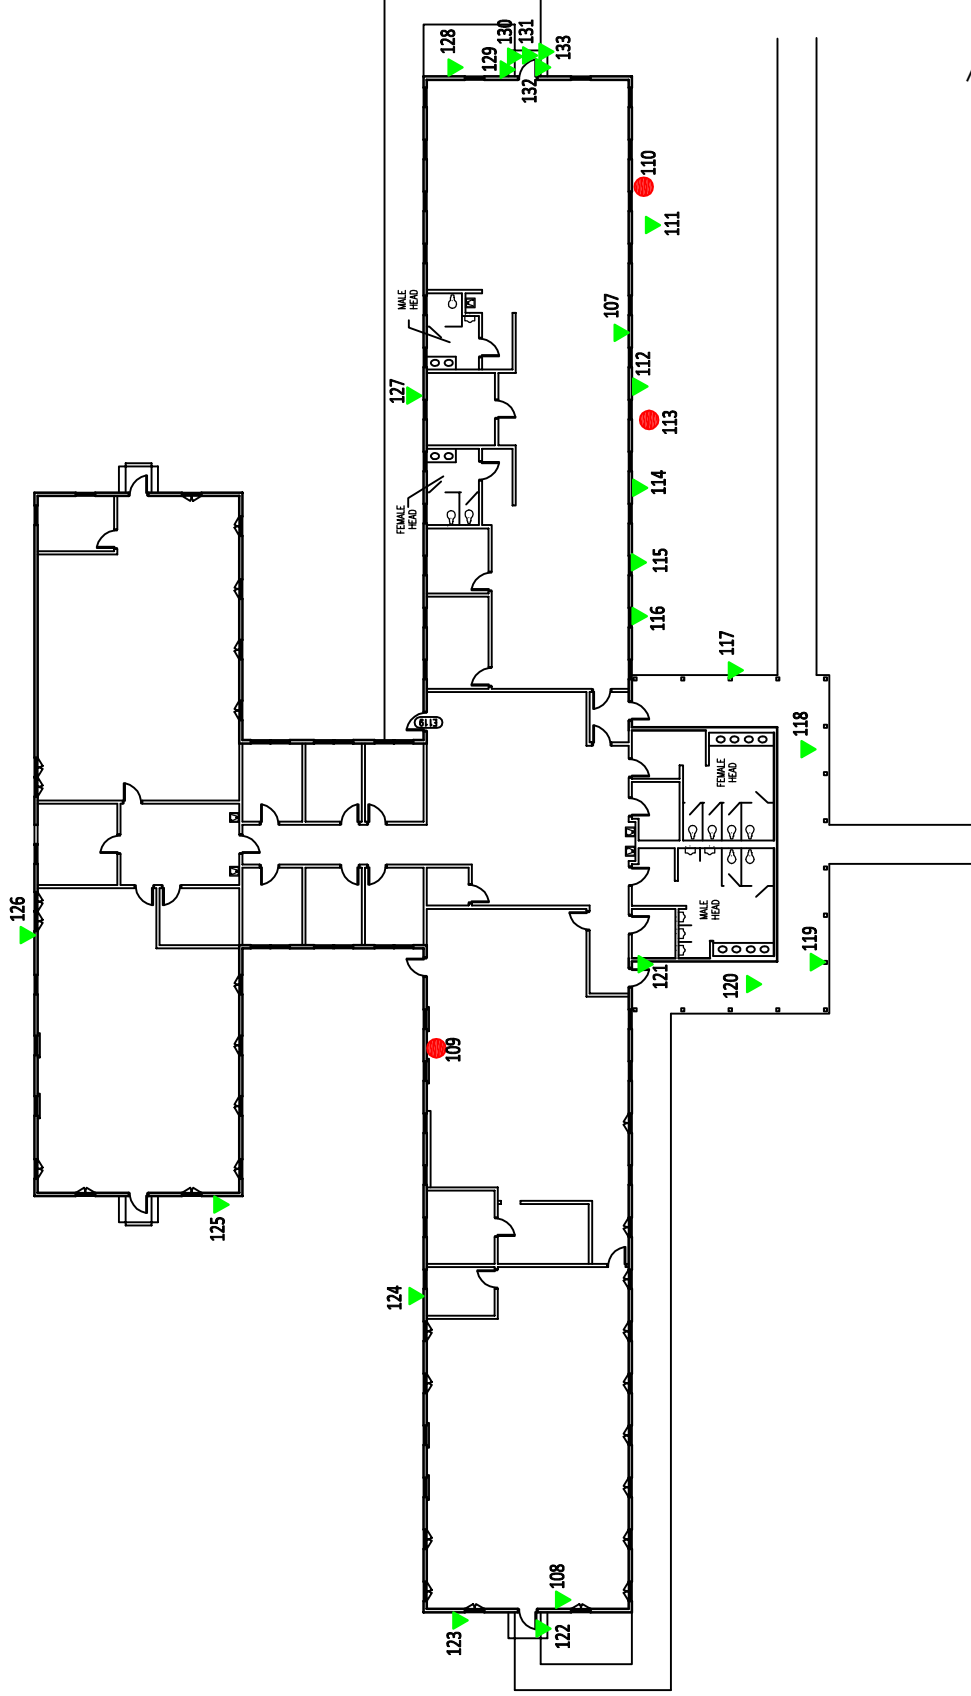
# LOCATION PLAN

TABLE 2 – SUMMARY OF LEAD-BASED PAINT FINDINGS						
FACILITY ID.	XRF TEST NO.	INT./EXT.	FEATURE	SUBSTRATE	COLOR	XRF RDG. <sup>1</sup>
M-101	109	Interior	Water Table	Concrete	White	> 1.0
M-101	110	Exterior	Roof Joist	Wood	White	> 5.0
M-101	113	Exterior	Soffit	Wood	White	> 5.0

Lead-based paint (LBP), i.e. paint that contains lead equal to or exceeding one milligram per square centimeter ( $1.0 \text{ mg/cm}^2$ ), was identified at three (3) locations on the painted surfaces tested at the building as shown in Table 2. ACES recommends that the lead paint on the various surfaces not be disturbed as a part of the repair/renovation activities unless necessary as a result of the repair and/or renovation. If the painted surfaces must be disturbed, removal of the LBP should be performed in accordance with local, state, and federal regulations.

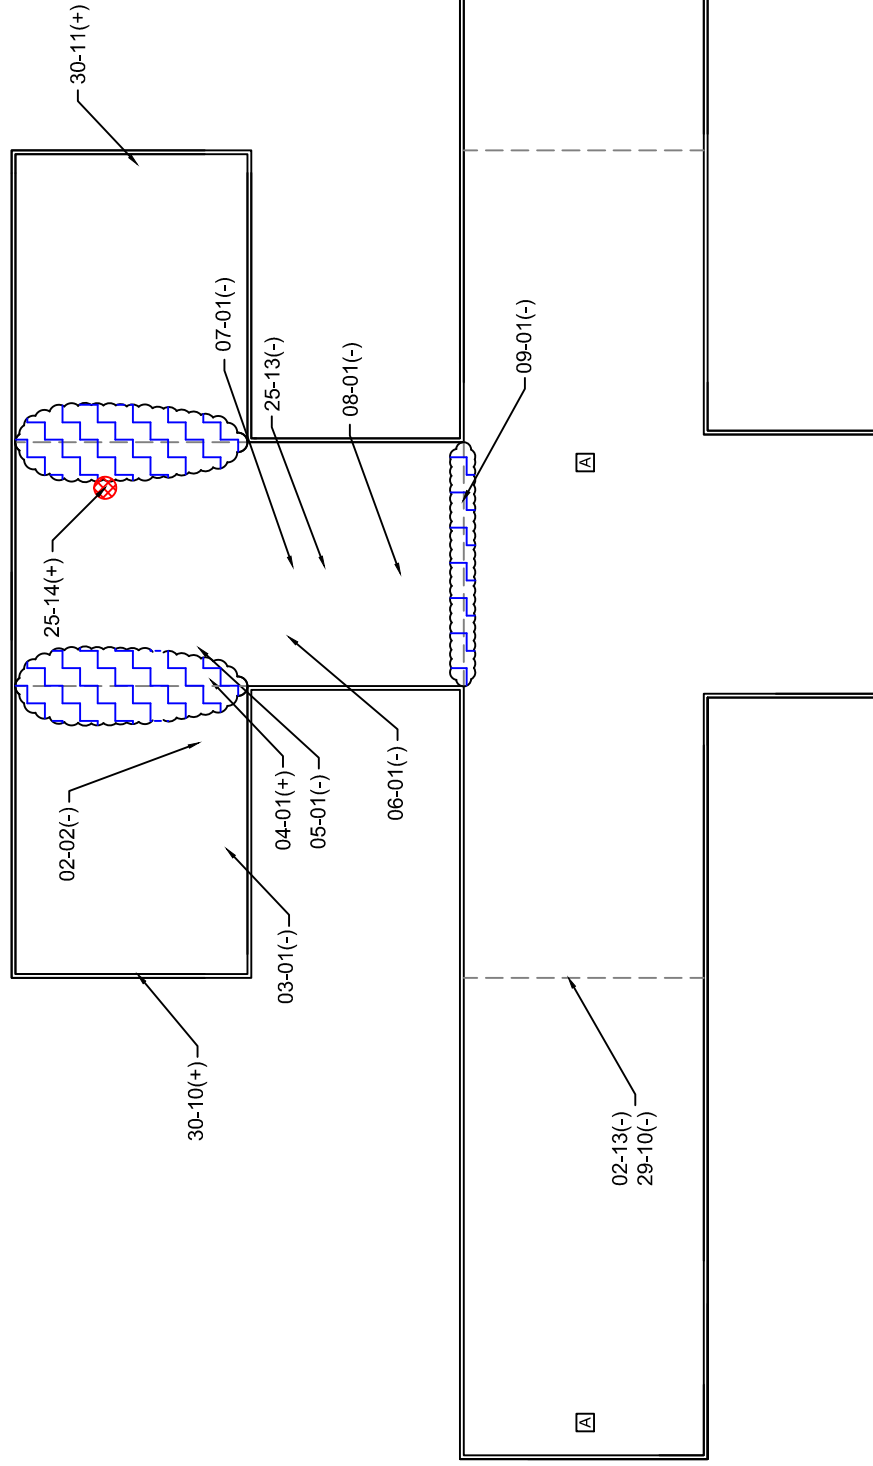
HAZ RANK 1C/RED [AH AUG2016]  
FIBROUS ACM DEBRIS IN ATTIC, EXTERIOR OVERHEAD.

# ACM FIBROUS DEBRIS IDENTIFIED ON ABANDONED PIPE HANGERS
