# **SURVEY REPORT FOR ASBESTOS AND LEAD-BASED PAINT**

**DELIVERY ORDER No. 0030  
RENOVATION, BLDG. M104 (MEDICAL TRAINING)  
MARINE CORPS BASE – CAMP JOHNSON  
JACKSONVILLE, NORTH CAROLINA**

**ISSUE DATE: SEPTEMBER 30, 2019**

**ACES PROJECT: 2019-05-037**

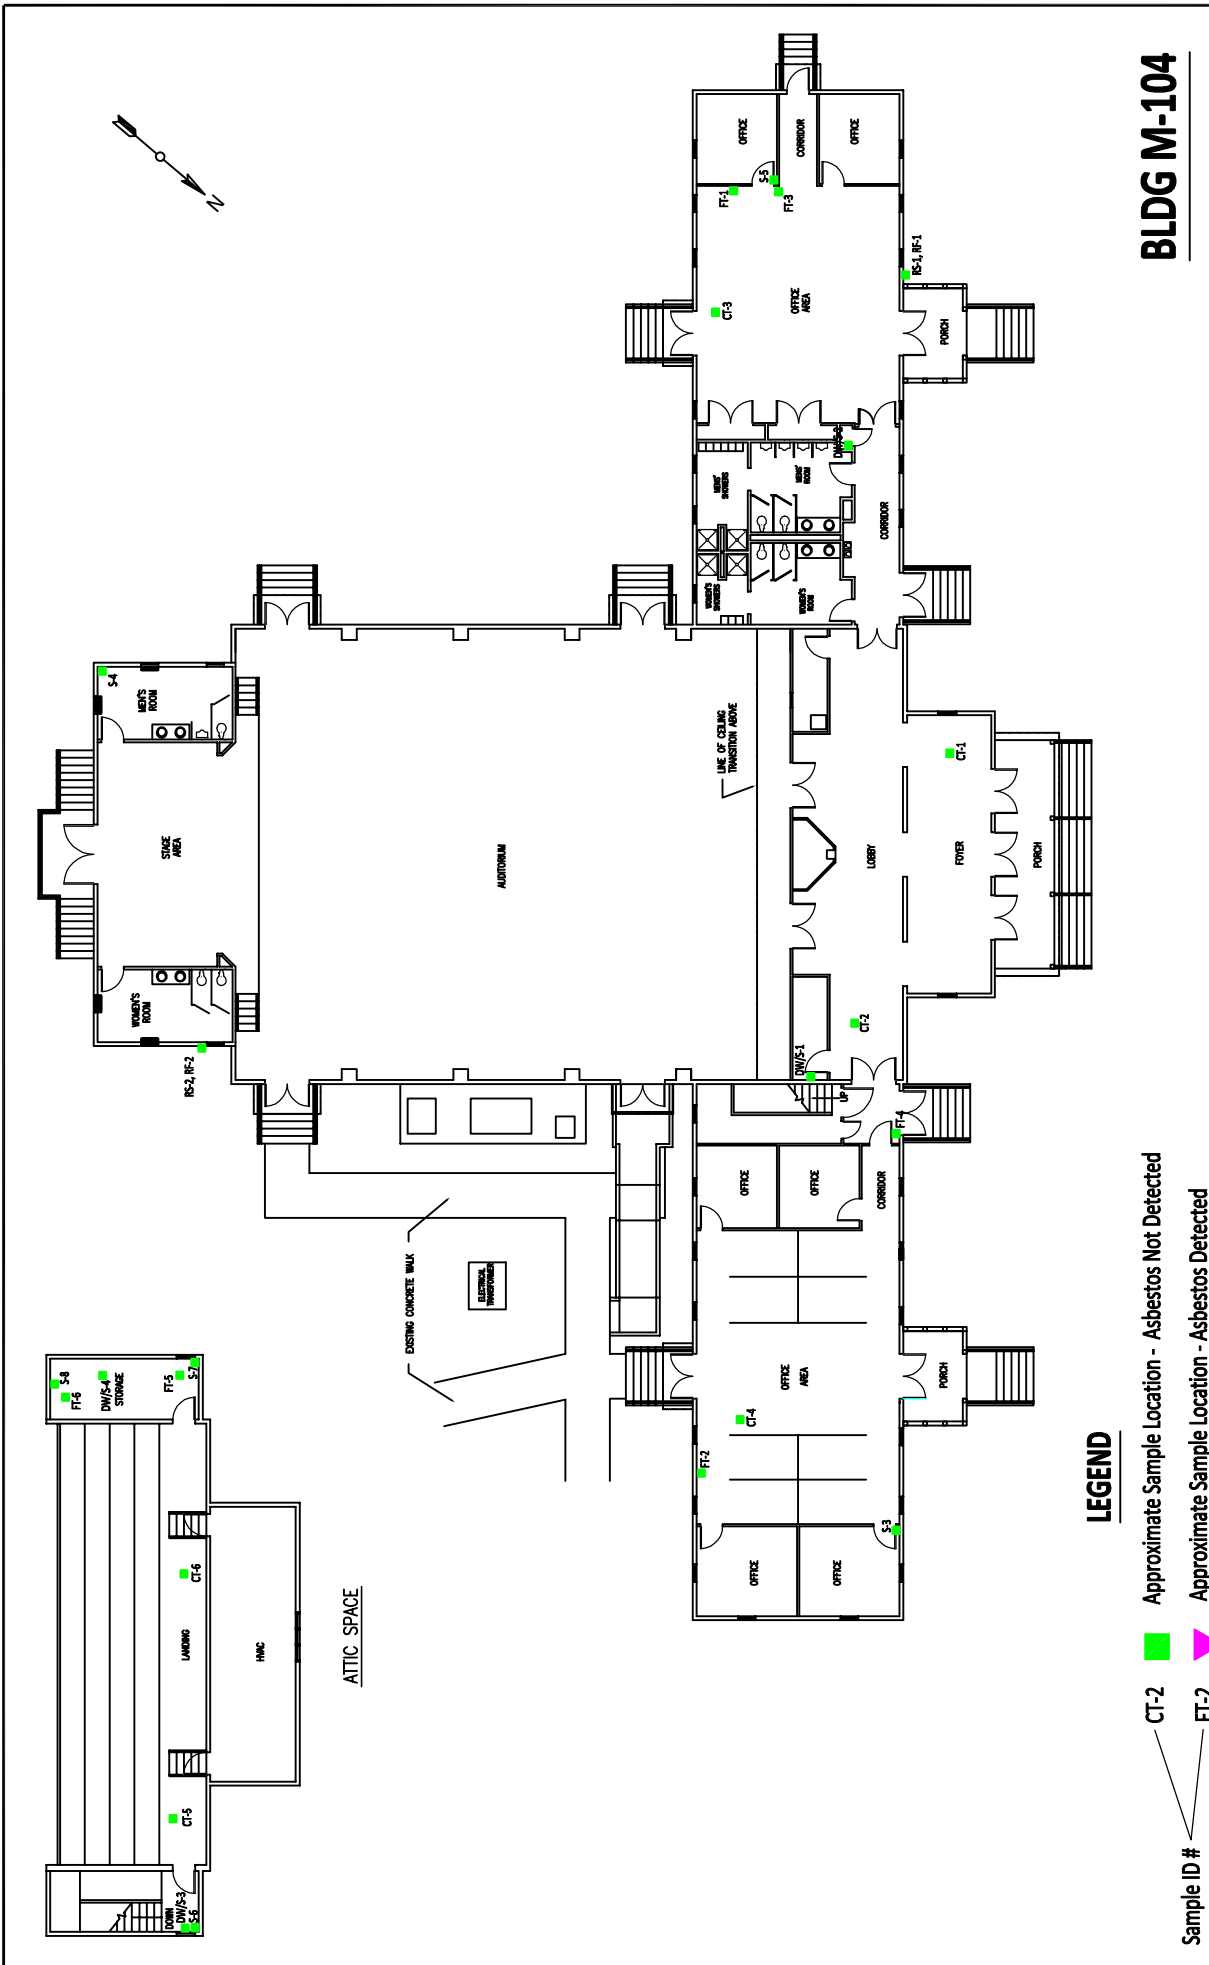
FIGURE  
**1**

Twenty-six (26) of the twenty-six (26) samples analyzed by EMSL did not contain asbestos (i.e. greater than one percent asbestos).

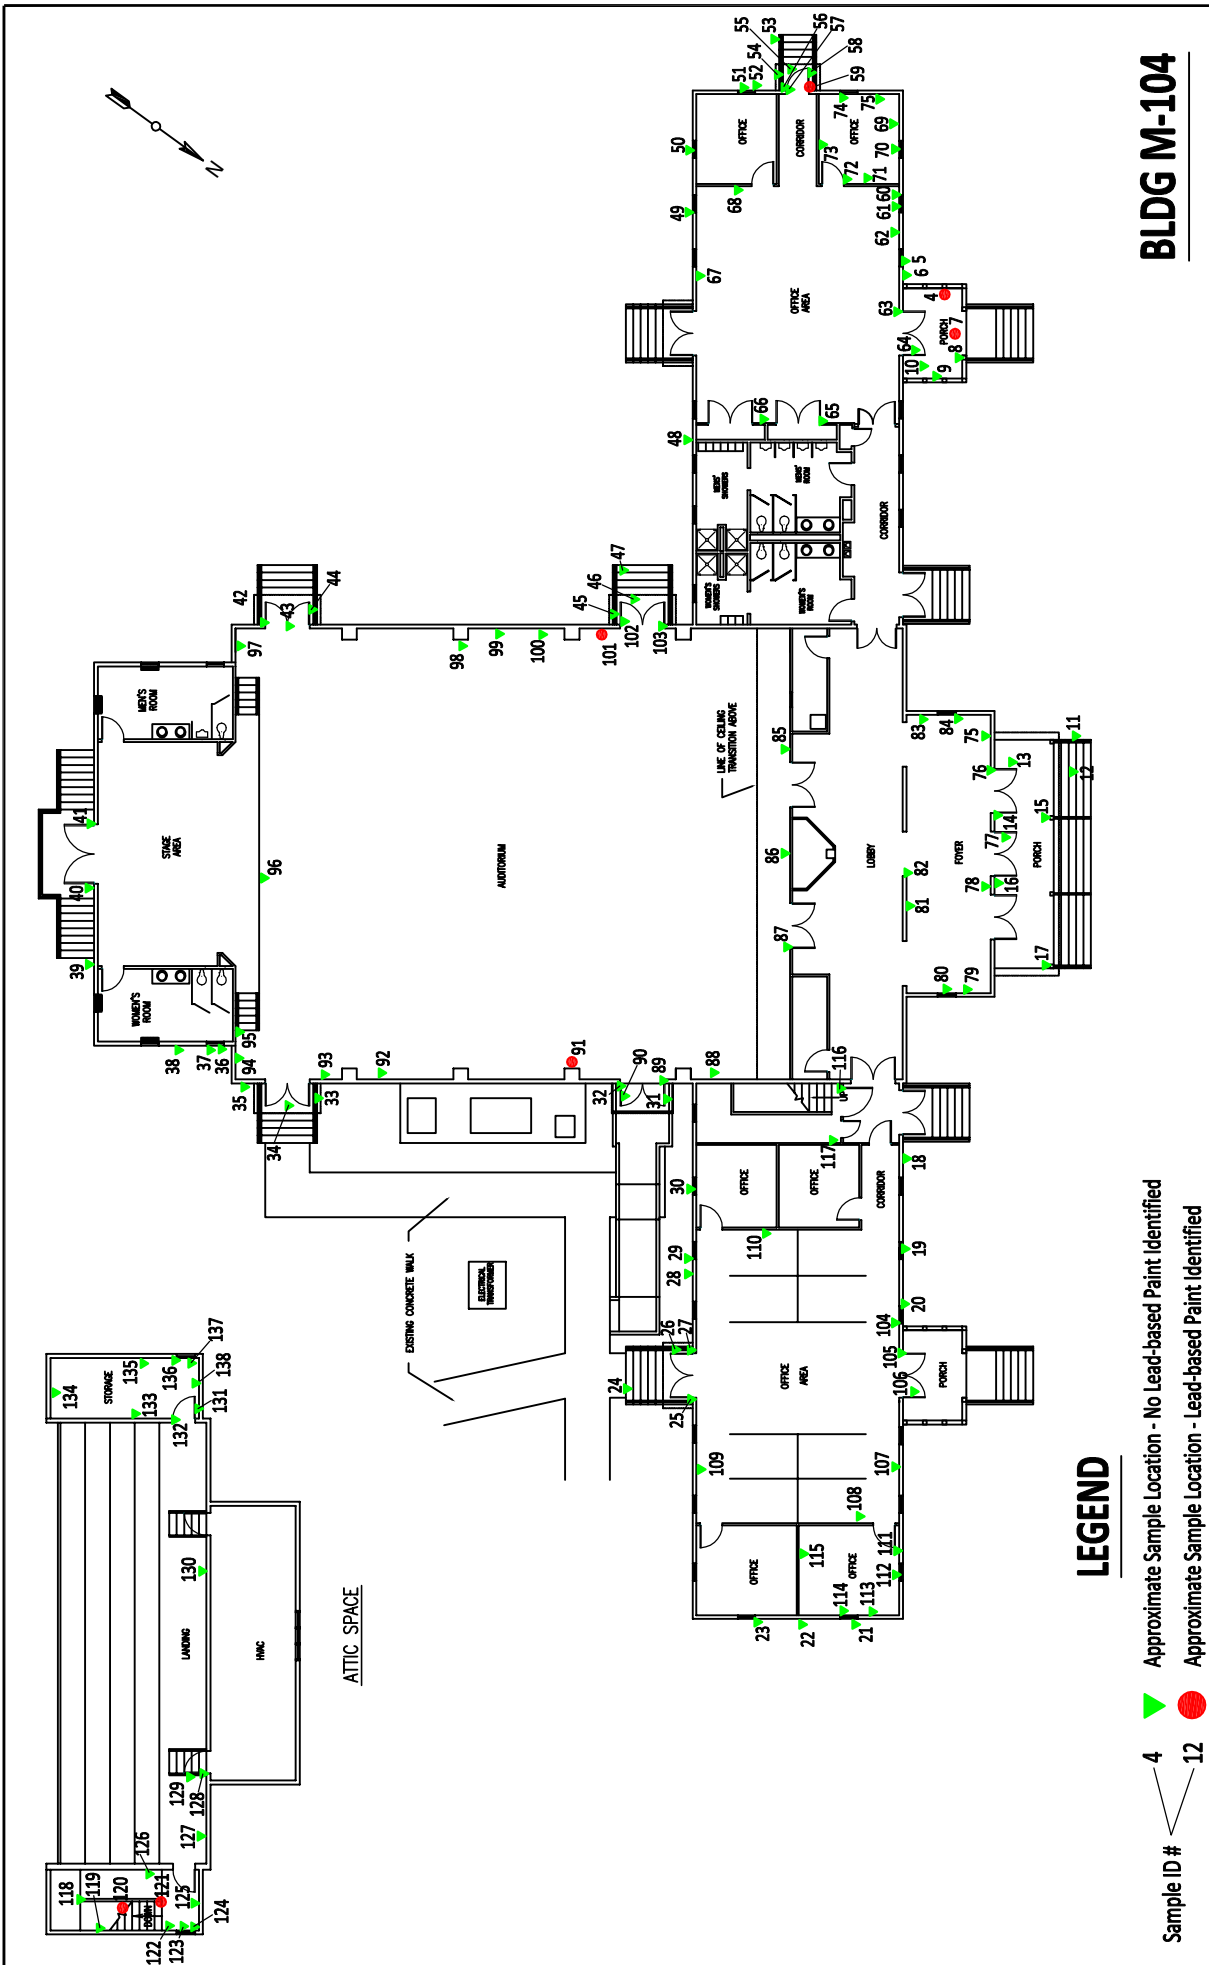
The results of the testing (Appendix 3) revealed that lead-based paint was present at seven (7) locations associated with Building M-104 as shown in Table 2.

TABLE 2 – SUMMARY OF LEAD-BASED PAINT FINDINGS						
FACILITY ID.	XRF TEST NO.	INT./EXT.	FEATURE	SUBSTRATE	COLOR	XRF RDG. <sup>1</sup>
M-104	4	Exterior	Half-wall (porch)	Wood	White	2.54
M-104	6	Exterior	Ceiling (porch)	Wood	White	> 5.0
M-104	59	Exterior	Door Casing	Metal	White	> 1.0
M-104	90	Interior	Column	Concrete	White	1.07
M-104	101	Interior	Wall	Concrete	White	1.09
M-104	120	Interior	Stair Frame	Wood	White	1.93
M-104	121	Interior	Newell Post	Wood	White	2.23

Lead-based paint (LBP), i.e. paint that contains lead equal to or exceeding one milligram per square centimeter (1.0 mg/cm<sup>2</sup>), was identified at seven (7) locations on the painted surfaces tested for the building as shown in Table 2. ACES recommends that the lead paint on the various surfaces not be disturbed as a part of the repair/renovation activities unless necessary as a result of the repair and/or renovation. If the painted surfaces must be disturbed, removal of the LBP should be performed in accordance with local, state, and federal regulations.

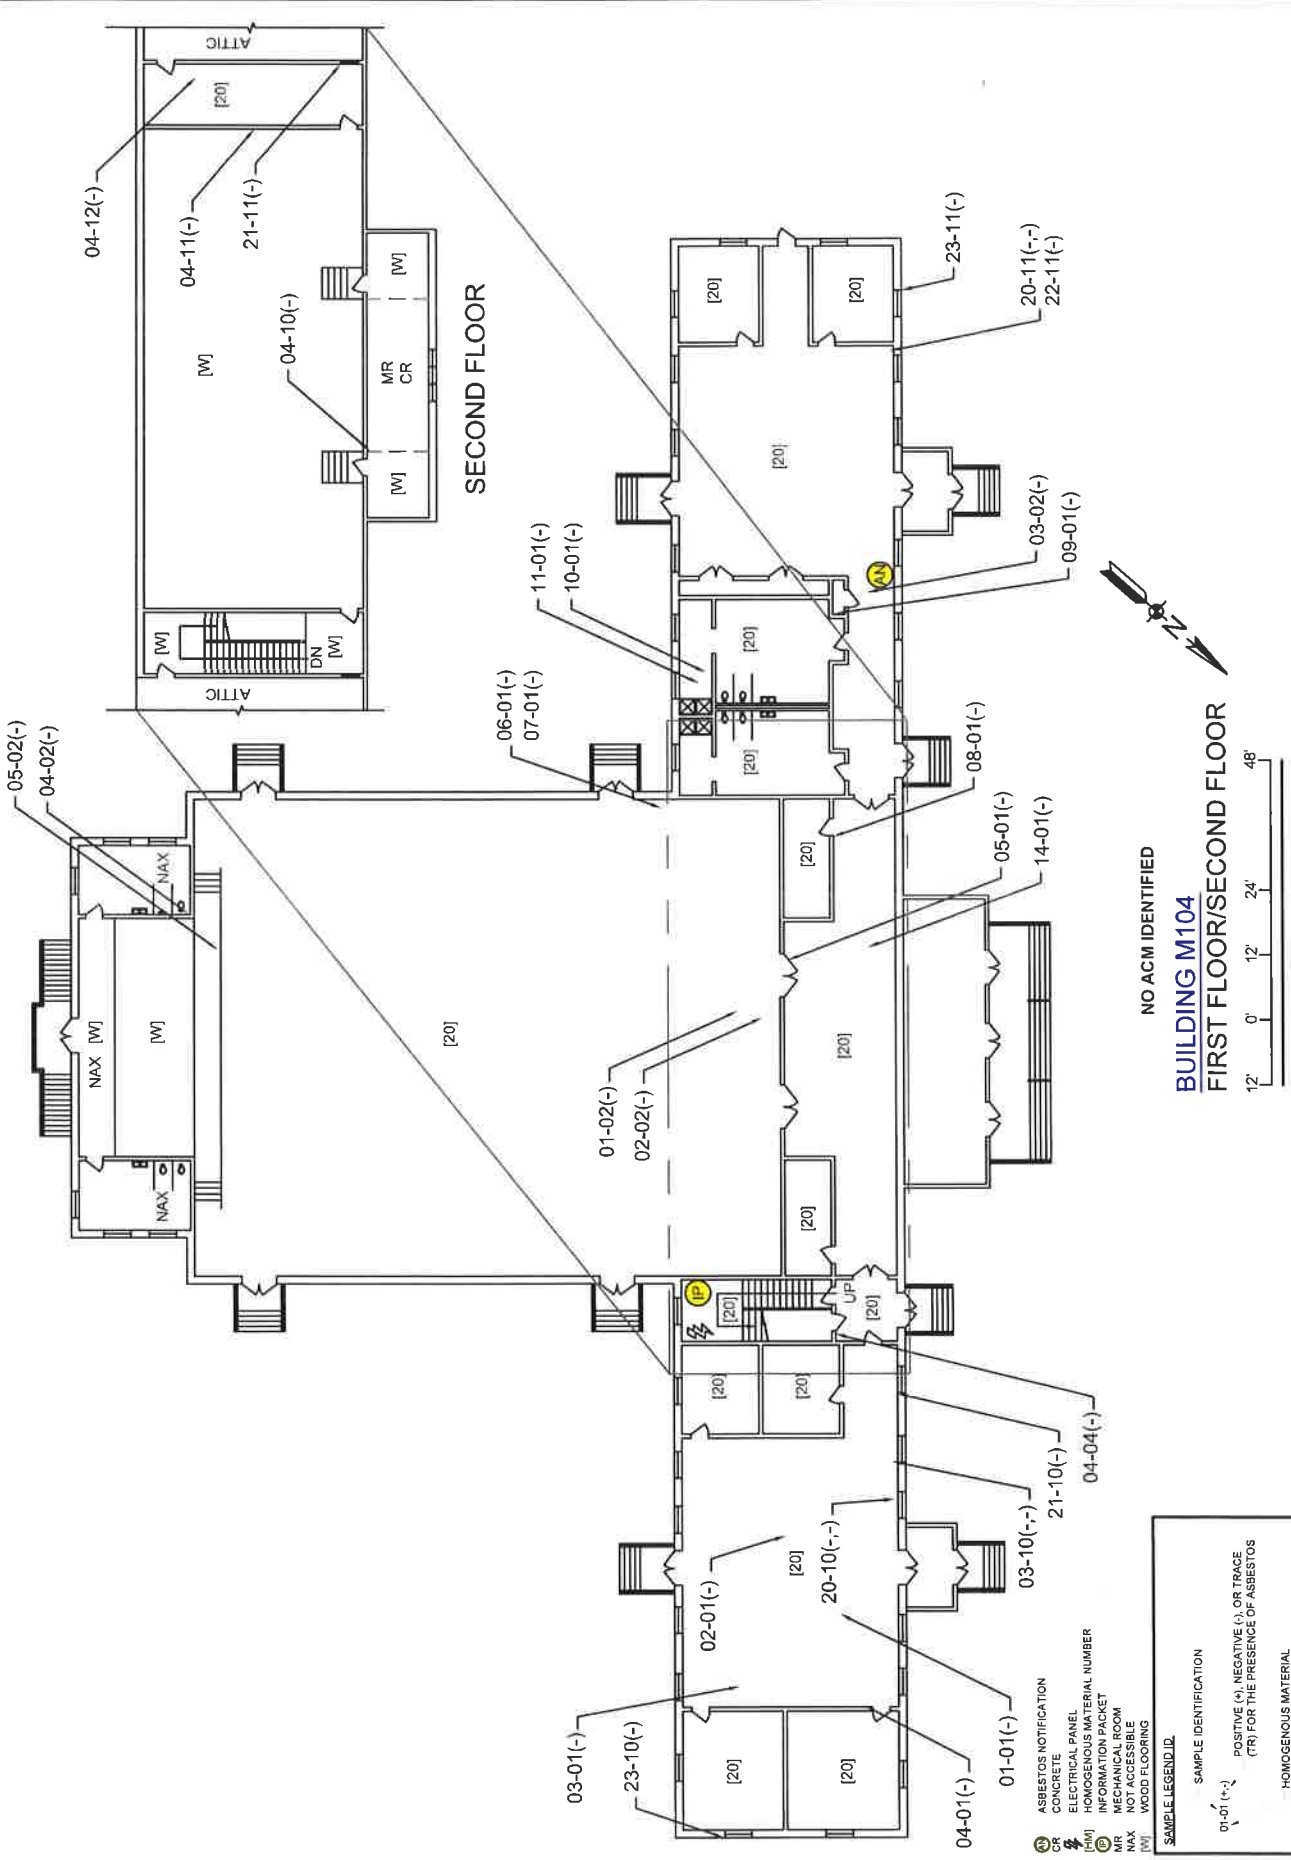
**BUILDING M104**  
**FIRST FLOOR/SECOND FLOOR**

NO ACM IDENTIFIED

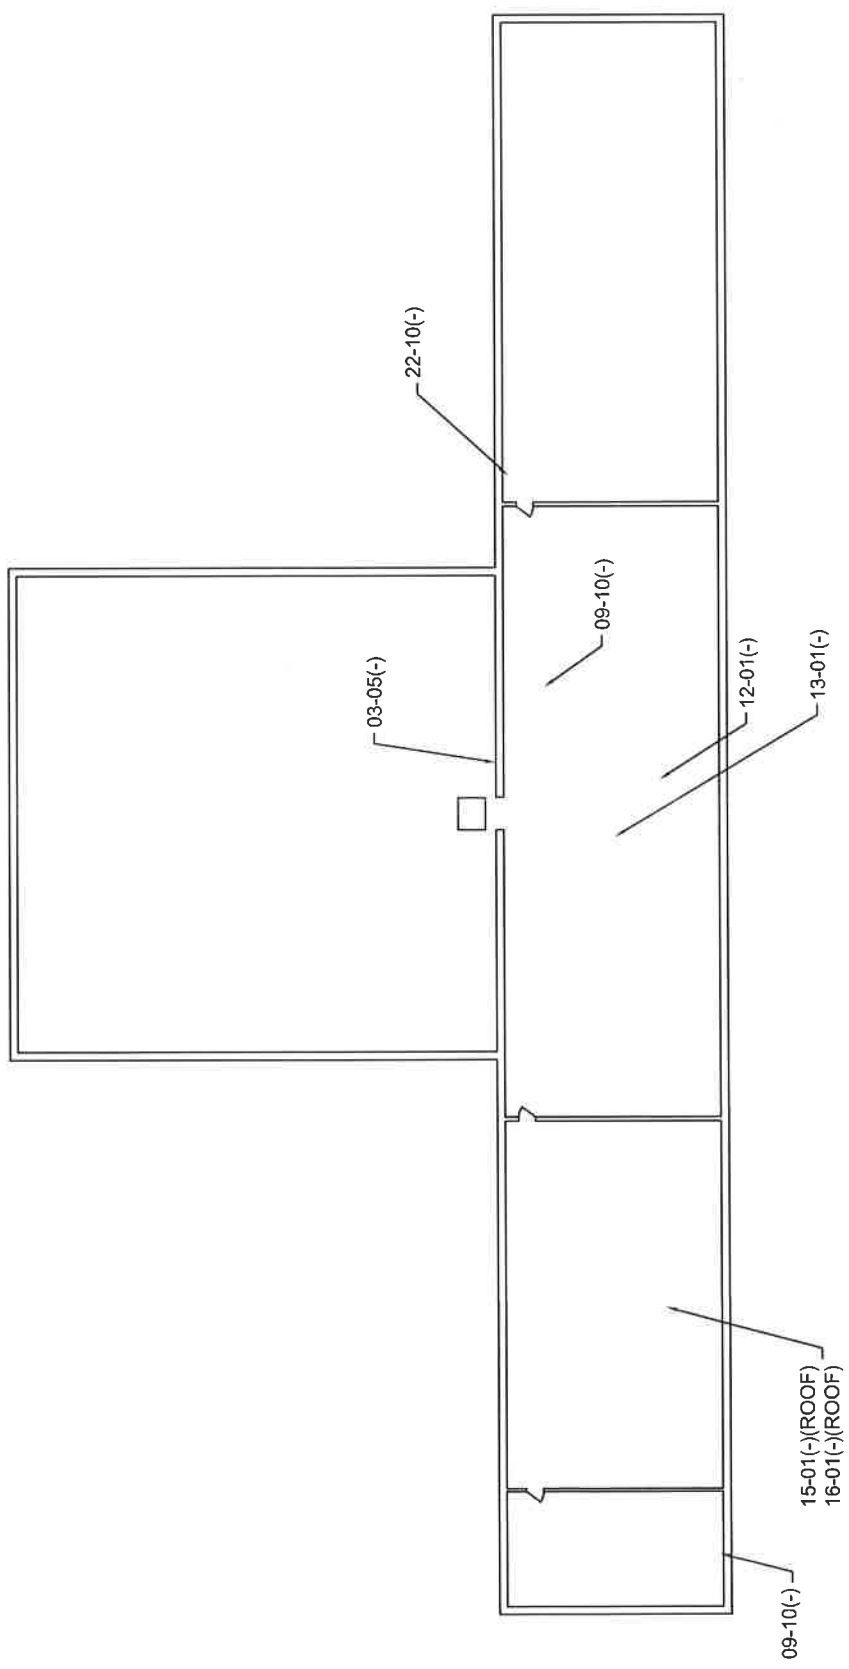
NO ACM IDENTIFIED  
**BUILDING M104**  
**ATTIC/ROOF**
