SURVEY REPORT FOR ASBESTOS AND LEAD-BASED PAINT

**DELIVERY ORDER NO. 0031
RENOVATE BLDG. M100
MARINE CORPS BASE – CAMP JOHNSON
JACKSONVILLE, NORTH CAROLINA**

ISSUE DATE: JUNE 5, 2019

ACES PROJECT: 2019-04-023

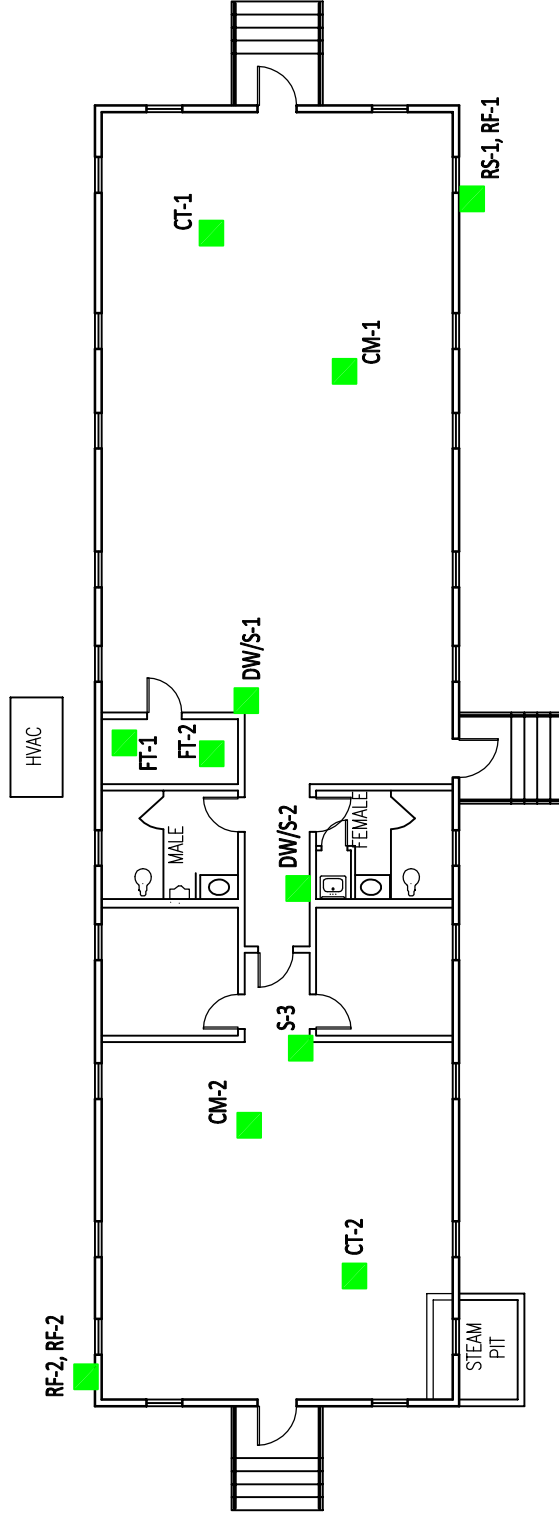
1

None of the seventeen (17) samples analyzed by EMSL contained asbestos (i.e. greater than one percent asbestos).

Asbestos was not detected in the seventeen (17) samples analyzed by EMSL. In addition, an asbestos report prepared by others indicated that friable and/or non-friable ACM was not present in the building.

Asbestos containing materials (ACM) and Presumed Asbestos Containing Materials (PACM) were not identified in the building. Based upon the sampling performed by ACES and a review of the results of the laboratory analysis and the review of the asbestos report prepared by others, no specialized asbestos procedures are required prior to renovation.

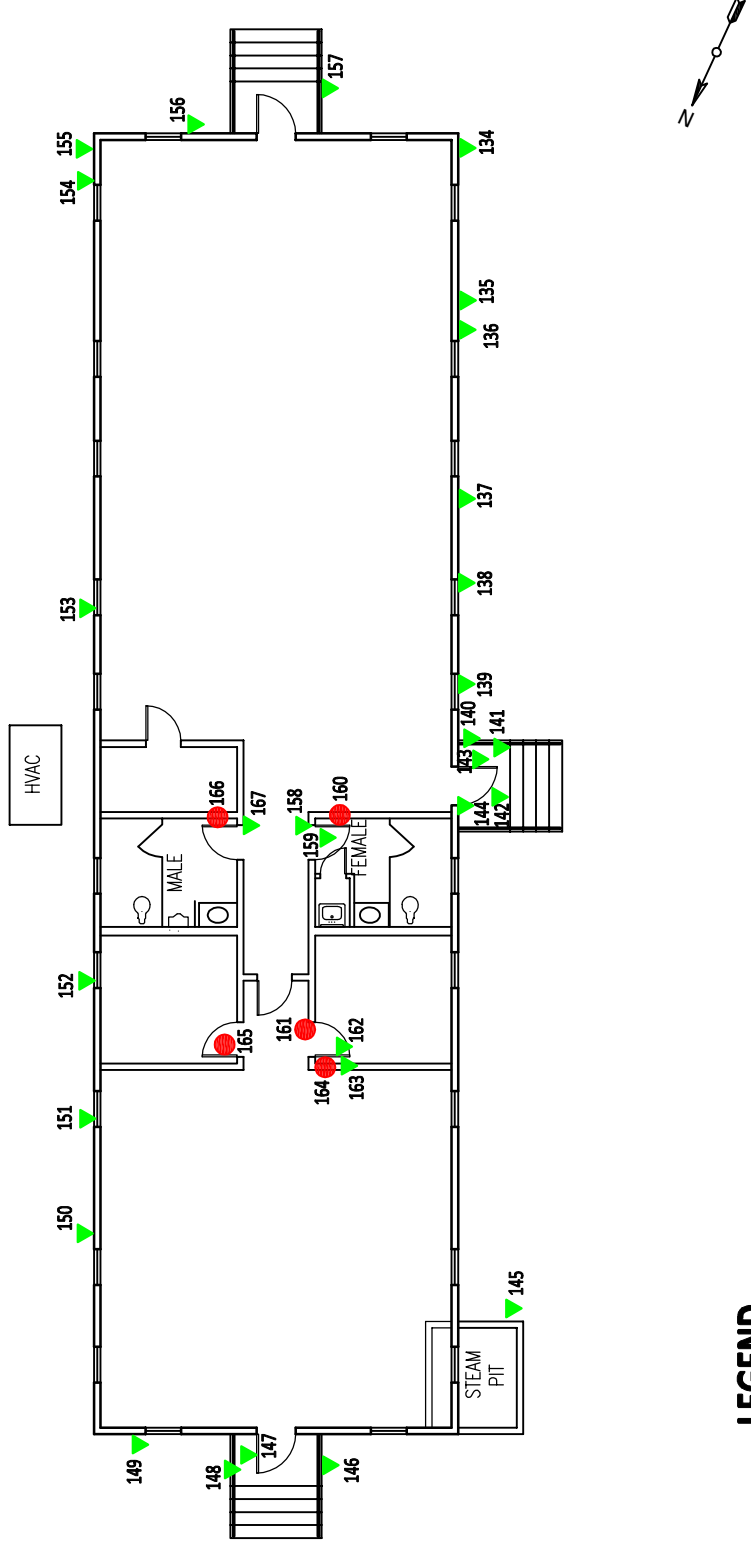
SAMPLE LOCATION PLAN

The results of the testing (Appendix 3) revealed that lead-based paint was present at five (5) locations associated with Building M-100 as shown in Table 2.

TABLE 2 – SUMMARY OF LEAD-BASED PAINT FINDINGS						
FACILITY ID.	XRF TEST NO.	INT./EXT.	FEATURE	SUBSTRATE	COLOR	XRF RDG. ¹
M-100	160	Interior	Door (back)	Wood	Off-white	4.8
M-100	161	Interior	Door frame	Wood	White	3.09
M-100	164	Interior	Wall	Wood	Green	> 5.0
M-100	165	Interior	Door (front)	Wood	Off-white	> 5.0
M-100	166	Interior	Door (back)	Wood	Off-white	3.63

Lead-based paint (LBP), i.e. paint that contains lead equal to or exceeding one milligram per square centimeter (1.0 mg/cm²), was identified at five (5) locations on the painted surfaces tested at the building as shown in Table 2. ACES recommends that the lead paint on the various surfaces not be disturbed as a part of the repair/renovation activities unless necessary as a result of the repair and/or renovation. If the painted surfaces must be disturbed, removal of the LBP should be performed in accordance with local, state, and federal regulations.
