ASBESTOS INSPECTION REPORT of:

Building # HP510

Comprehensive Interior/Exterior Asbestos Survey Report

HP510 - BEQ
Marine Corps Base
Camp Lejeune, North Carolina

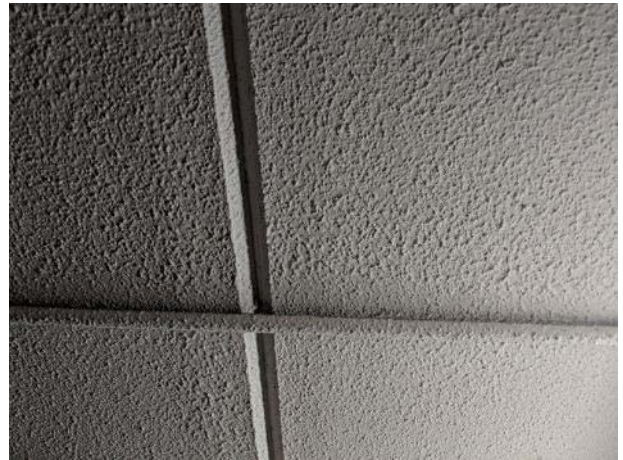
HA-1: Spray-on Ceiling Texture

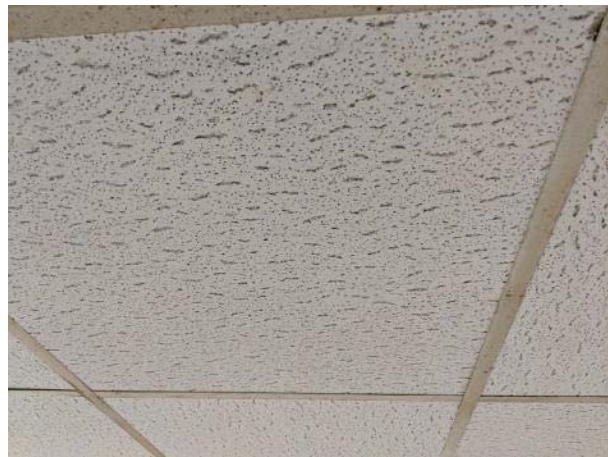
HA-2: 2'x 2' Cellulose Ceiling Tile

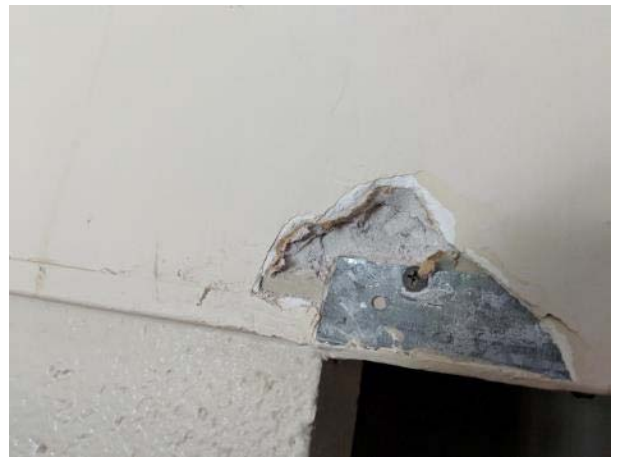
HA-3: Gypsum Board

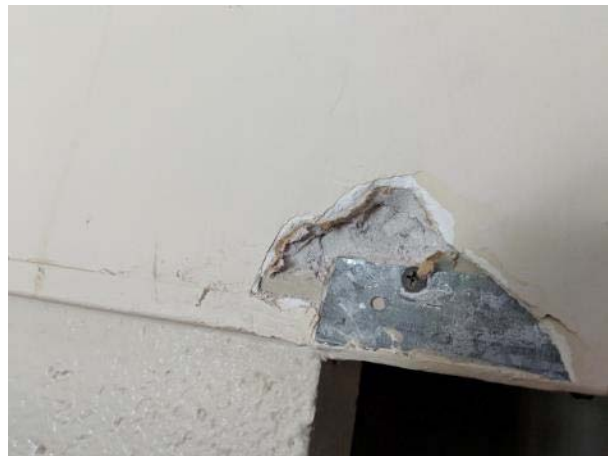
HA-4: Joint Compound

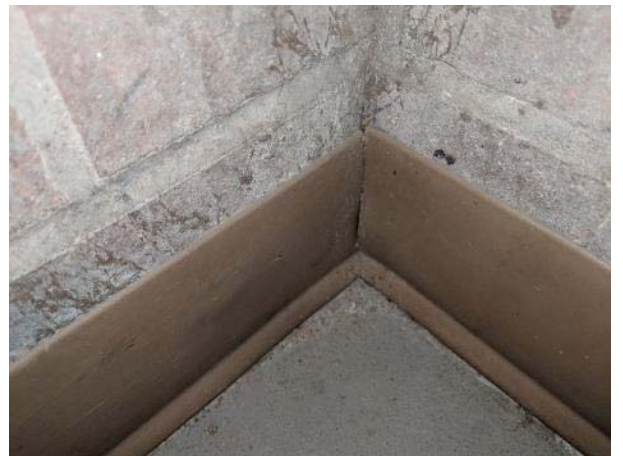
HA-5: Cove Base Mastic

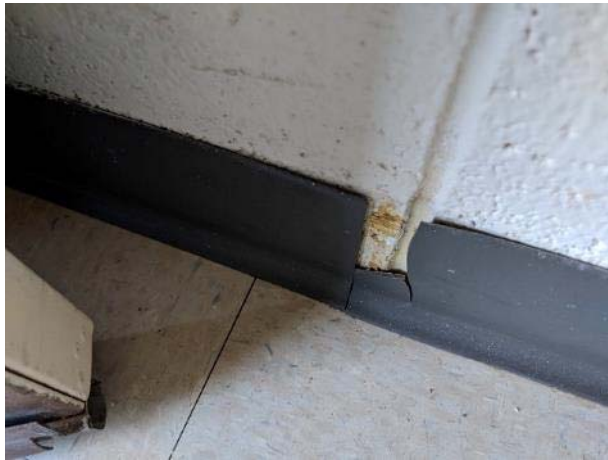
HA-6: Cove Base Mastic

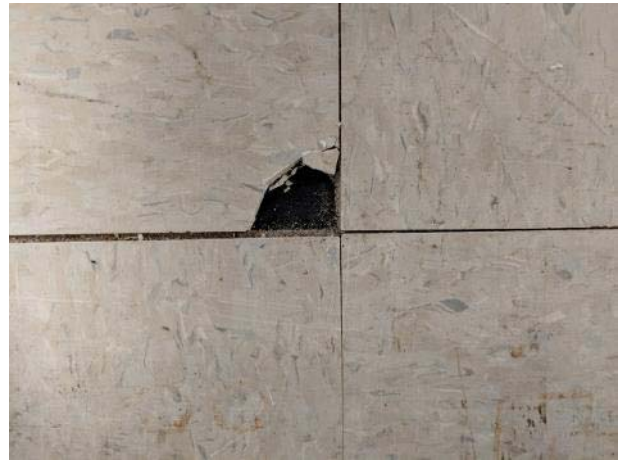
510-7-16 291803843-0016	1'x1' Vinyl Floor Tile	Tan Non-Fibrous Homogeneous		100% Non-fibrous (Other)	None Detected

HA-7: 1' x 1' Vinyl Floor Tile

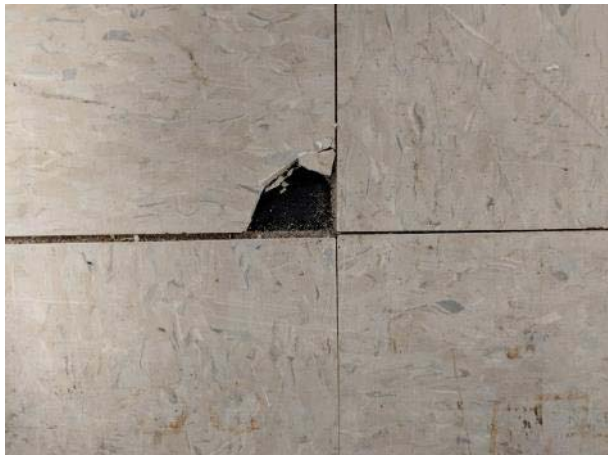
HA-8: Mastic Associated with HA-7

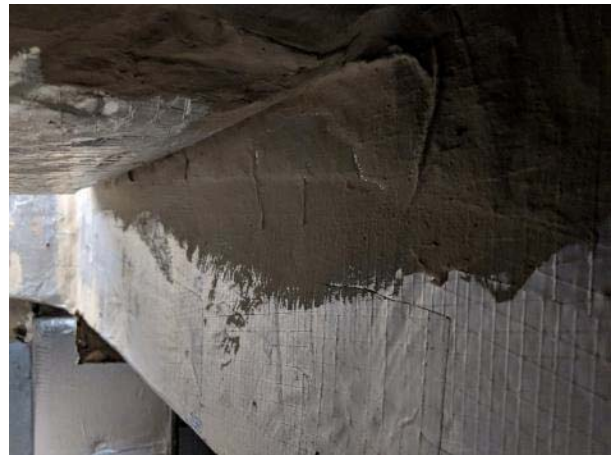
HA-9: HVAC Duct Insulation Mastic

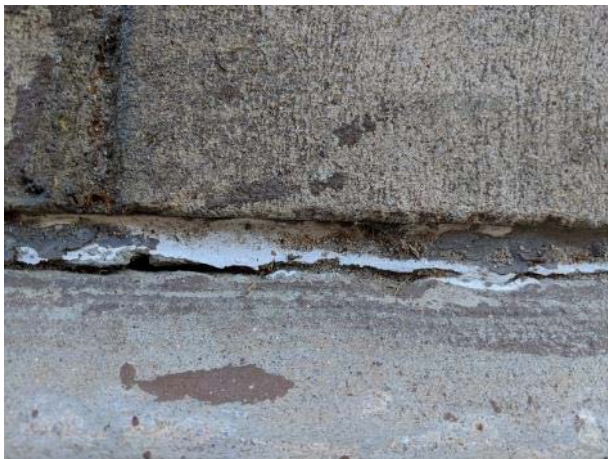
HA-10: Exterior Expansion Joint Caulk

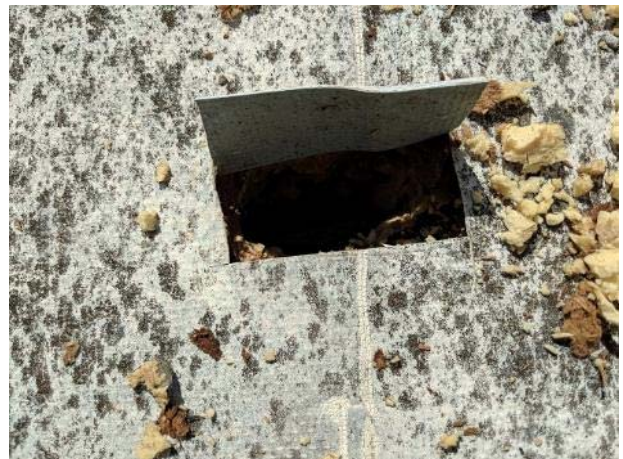
HA-11: Rubber Roofing Membrane/Mastic

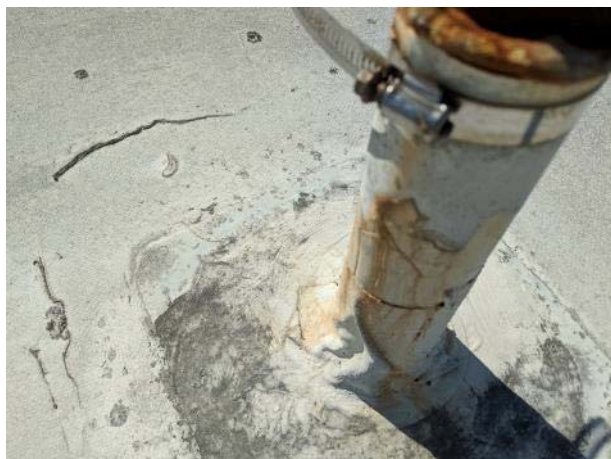
510-12-27 291803843-0027	Vent Pipe Penetration	White Non-Fibrous Homogeneous		100% Non-fibrous (Other)	None Detected

HA-12: Penetration Mastic

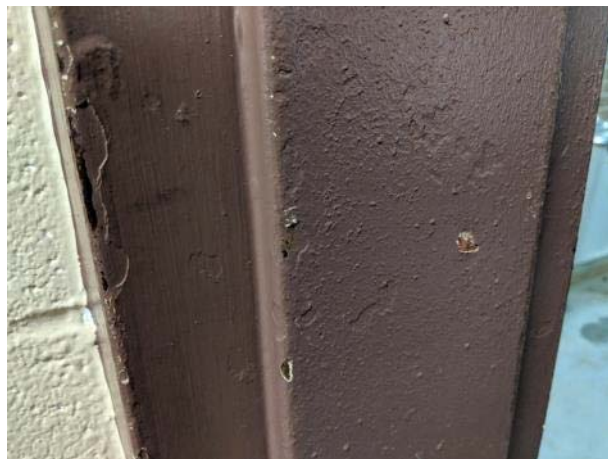
Pb-01: Door/Door Frame

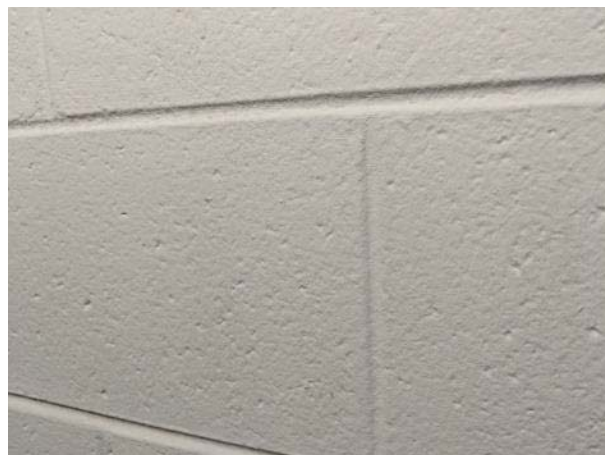
Pb-02: Interior Walls
