CLARIFICATION NO. 4

North Carolina Aquariums at Fort Fisher Expansion + Renovation

FORT FISHER AQUARIUM EXPANSION PROJECT – HAZARDOUS MATERIALS REVIEW

Reference: **Limited Hazardous Materials Assessment Report**
NC Aquarium Fort Fisher Addition and Renovation
Kure Beach, North Carolina
S&ME Project No. 23060119

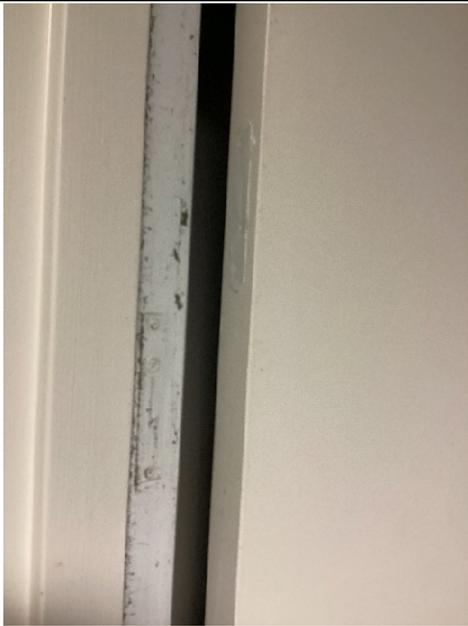
1/29/2024
		Photographer: Benjamin Best
1	Location / Material Description	Entry Building / Fire Doors (L)
	Remarks	Assumed asbestos containing. This building material is typically not sampled, due to the potential of voiding the warranty.

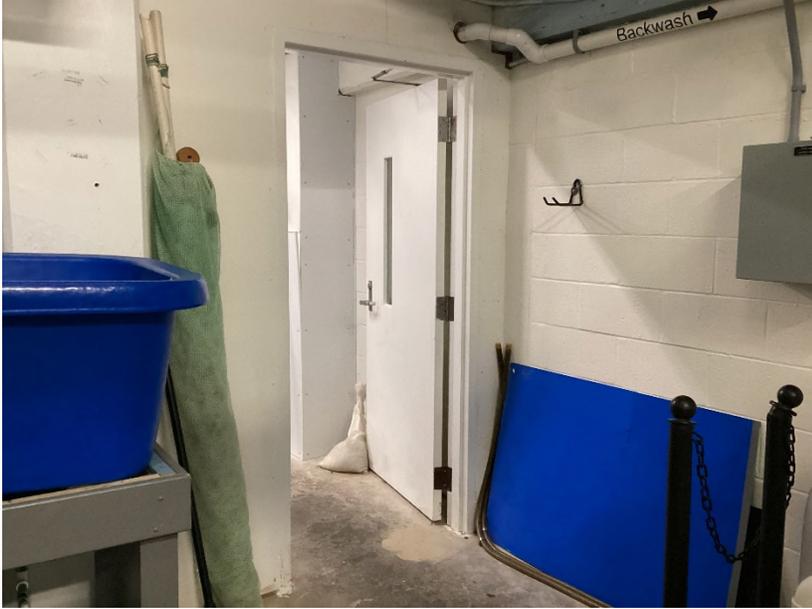
2/8/2024
		Photographer: Benjamin Best
2	Location / Material Description	Main Exhibit Building, East Wing / Fire Doors (AF)
	Remarks	Assumed asbestos containing. This building material is typically not sampled, due to the potential of voiding the warranty.

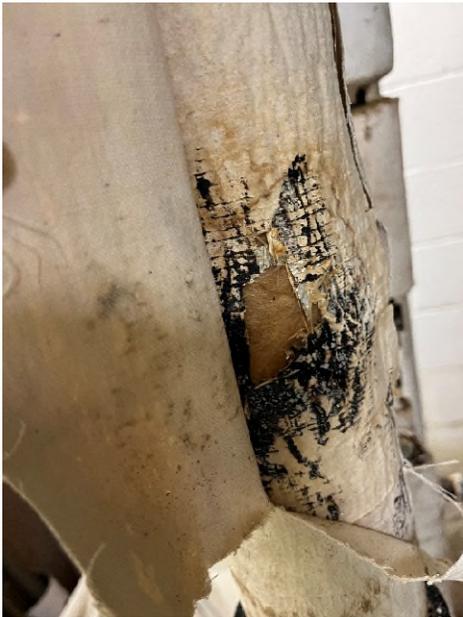
2/8/2024
		Photographer: Benjamin Best
3	Location / Material Description	Main Exhibit Building, East Wing / Black Mastic Between Paper and Fiberglass Insulation, 4" Chilled Water Lines (CG, BN)
	Remarks	Laboratory report indicates 5% chrysotile in the mastic.

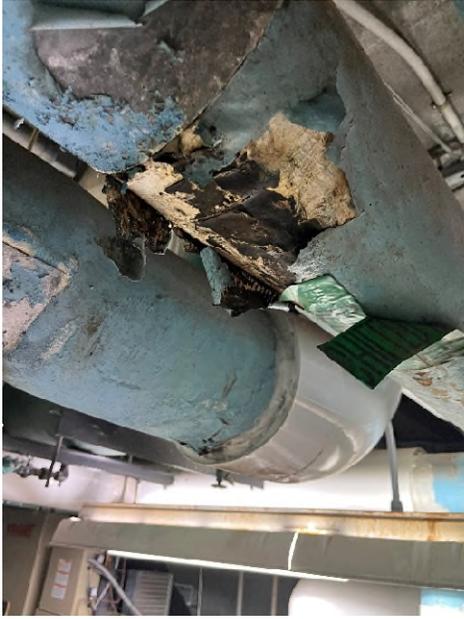
2/8/2024
		Photographer: Benjamin Best
4	Location / Material Description	Main Exhibit Building, East Wing / Black Mastic Between Paper and Fiberglass or Foam Insulation, 6-8" Chilled Water Lines (CN). Black Mastic is Also Present Under Hard Fittings.
	Remarks	Laboratory report indicates 10% chrysotile in the mastic.

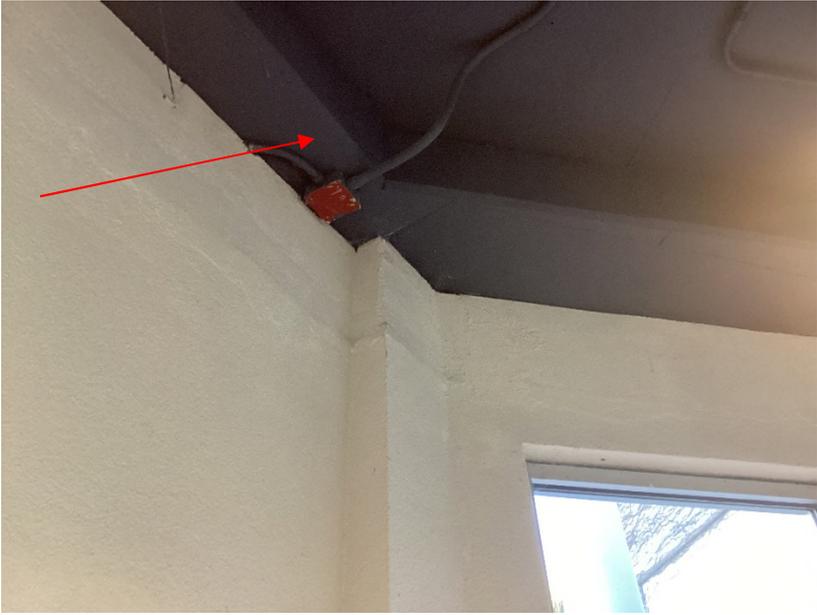
1/29/2024
		Photographer: Benjamin Best
1	Location / Material Description	Entry Building / Dark Blue Paint on Ceiling (Pb-10)
	Remarks	Laboratory Report indicates a lead concentration of 0.0041% by weight.

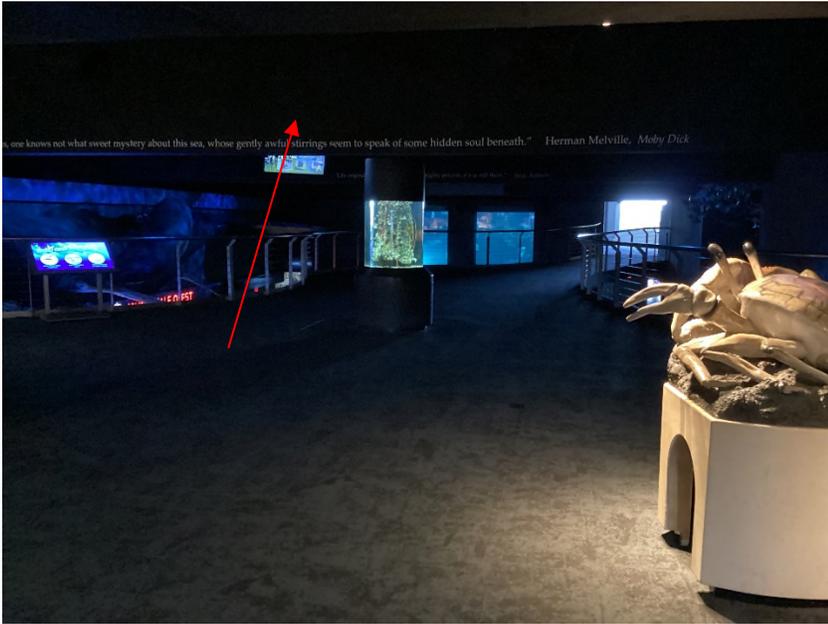
1/29/2024
		Photographer: Benjamin Best
2	Location / Material Description	Main Exhibit Building, East Wing / Black Paint on Ceiling (Pb-19)
	Remarks	Laboratory report indicates a lead concentration of 0.0035% by weight.

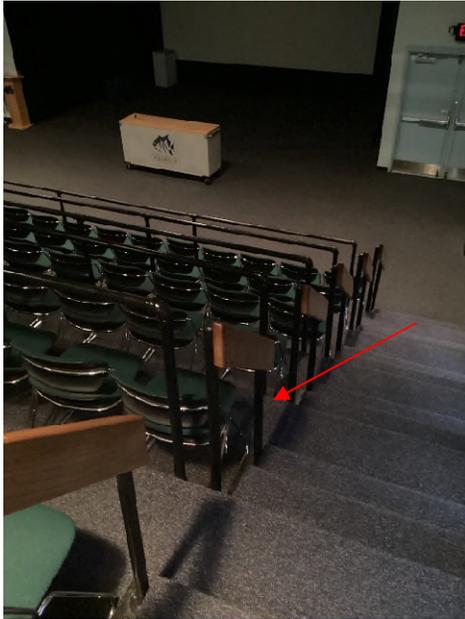
2/8/2024
		Photographer: Benjamin Best
3	Location / Material Description	Main Exhibit Building, East Wing / Black Paint on Handrails (Pb-29)
	Remarks	Laboratory Report indicates a lead concentration of 0.0052% by weight.

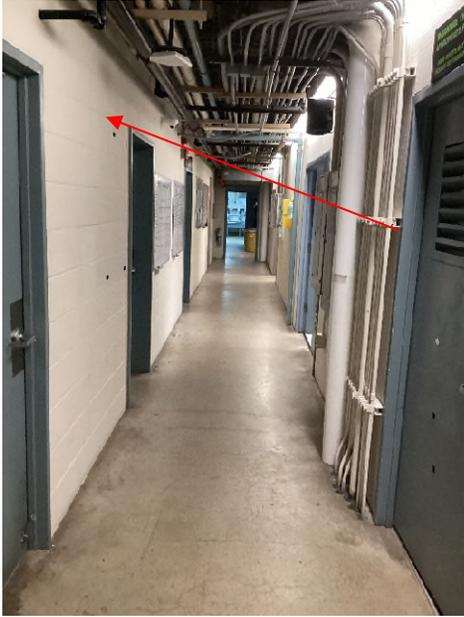
2/8/2024
				Photographer: Benjamin Best
4	Location / Material Description	Main Exhibit Building, East Wing / White Paint on CMU Wall (Pb-39)		
	Remarks	Laboratory report indicates a lead concentration of 0.0091% by weight.

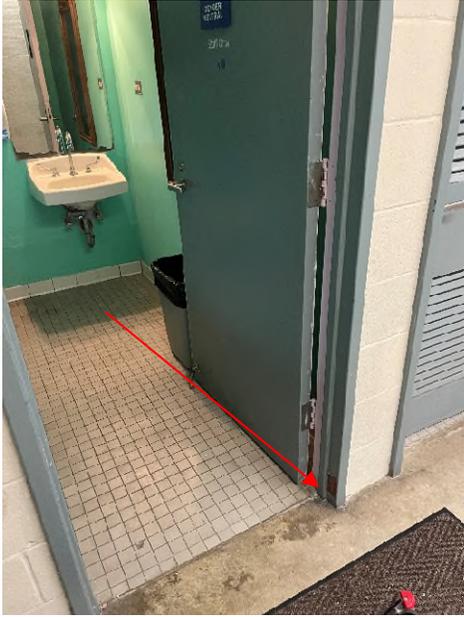
2/8/2024
				Photographer: Benjamin Best
5	Location / Material Description	Main Exhibit Building, East Wing / Light Blue Paint on Doors and Frames (Pb-42)		
	Remarks	Laboratory Report indicates a lead concentration of 0.017% by weight.

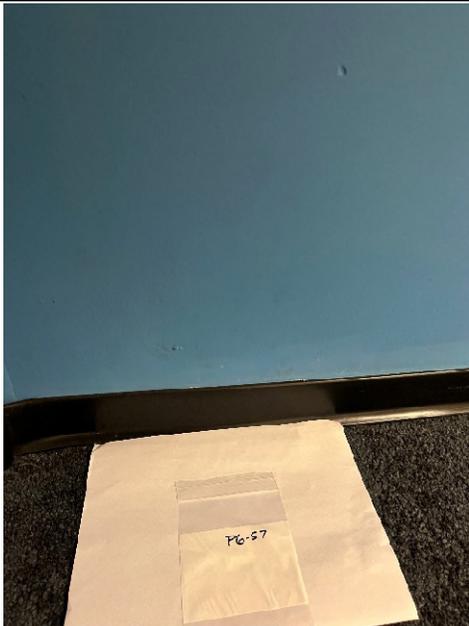
2/12/2024
			Photographer: Benjamin Best
6	Location / Material Description	Main Exhibit Building, East Wing / Dark Blue Paint on Drywall and CMU (Pb-57)	
	Remarks	Laboratory report indicates a lead concentration of 0.0047% by weight.

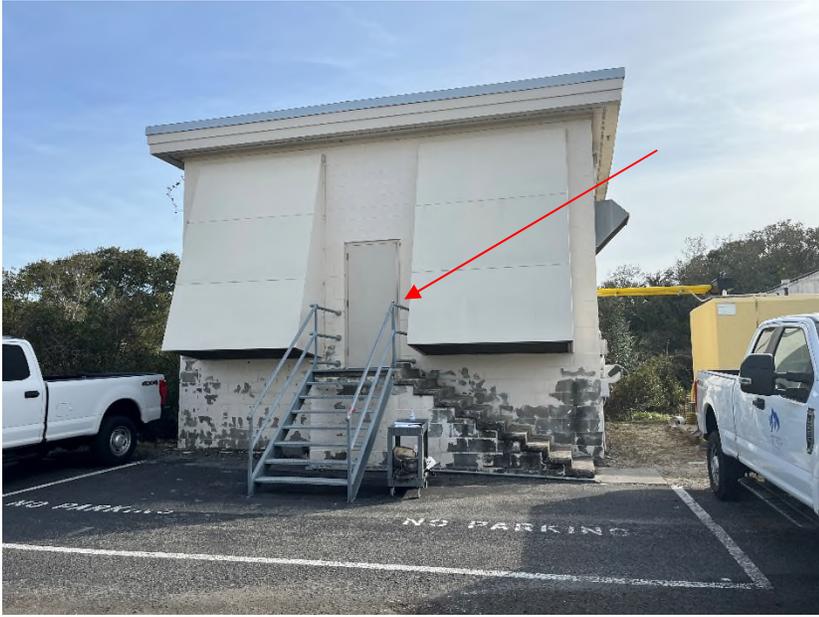
2/13/2024
		Photographer: Benjamin Best
1	Location / Material Description	Generator Building / Door Caulk (PCB-1)
	Remarks	Laboratory report indicates no PCBs detected.

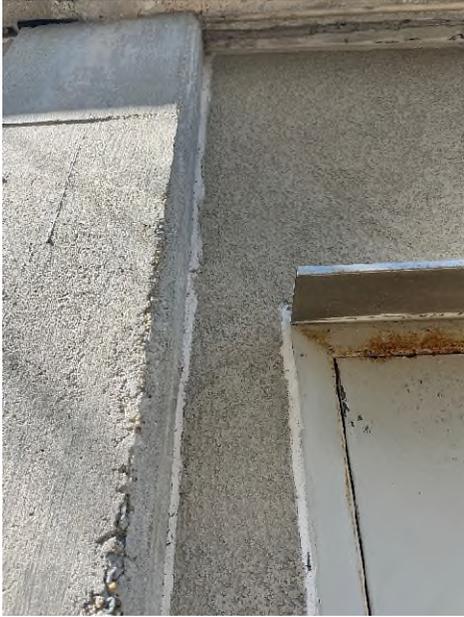
2/13/2024
			Photographer: Benjamin Best
2	Location / Material Description	Main Exhibit Building, East Wing / Exterior Door, Window, and Expansion Caulk (PCB-2)	
	Remarks	Laboratory report indicates no PCBs detected.

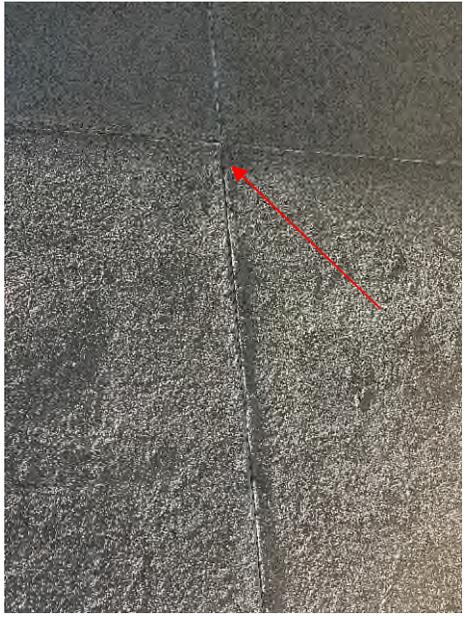
2/13/2024
			Photographer: Benjamin Best
3	Location / Material Description	Main Exhibit Building, East Wing / Stucco Panel Caulk (PCB-3)	
	Remarks	Laboratory report indicates no PCBs detected.

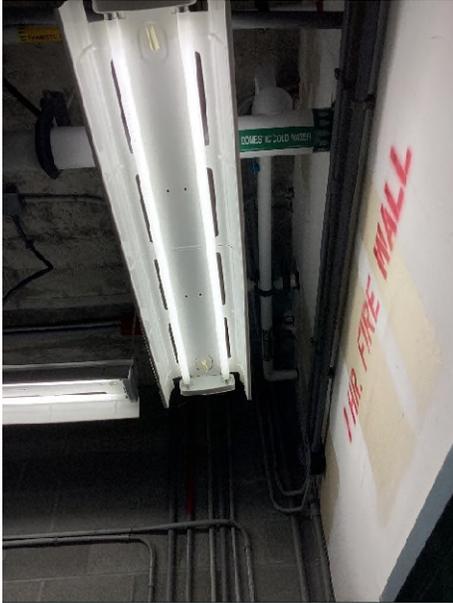
1/29/2024
				Photographer: Benjamin Best
1	Location / Material Description	Entry Building / Fluorescent Light Fixture (Linear Bulb)		
	Remarks	Typical view of fluorescent light fixture ballast that may contain PCBs, and fluorescent light bulbs can contain mercury.

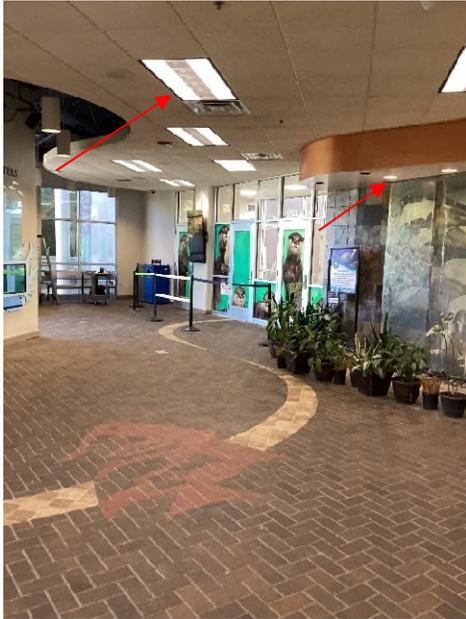
1/29/2024
				Photographer: Benjamin Best
2	Location / Material Description	Entry Building / Fluorescent Light Fixture (U-shape Bulbs)		
	Remarks	Typical view of fluorescent light fixture ballast that may contain PCBs, and fluorescent light bulbs can contain mercury.

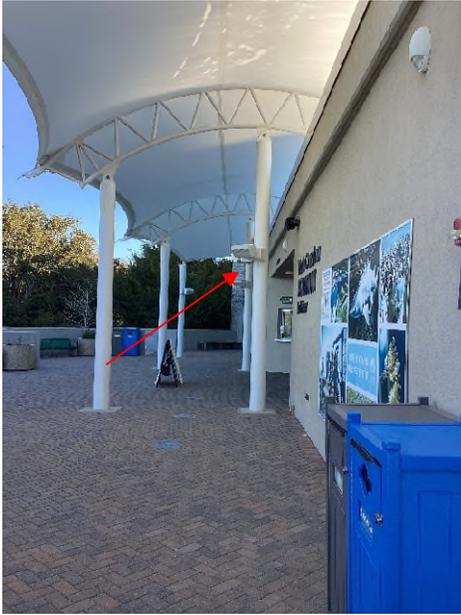
1/29/2024
			Photographer: Benjamin Best
3	Location / Material Description	Entry Building / High Intensity Light Fixture	
	Remarks	Typical view of high intensity light fixture ballast that may contain PCBs, and fluorescent light bulbs can contain mercury.

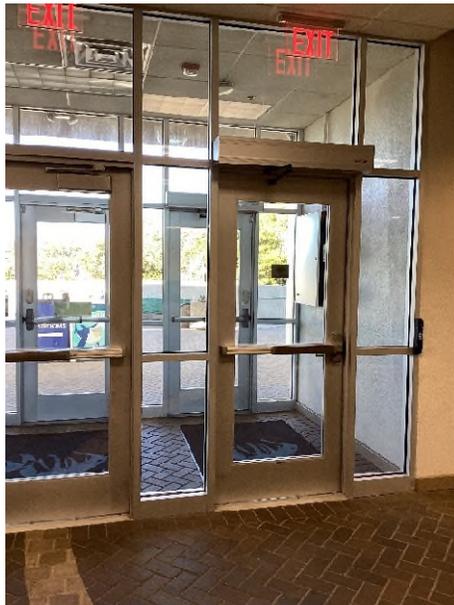
1/29/2024
			Photographer: Benjamin Best
4	Location / Material Description	Entry Building / Exit Signs	
	Remarks	Typical view of exit signs that may be connected to backup lead acid batteries.

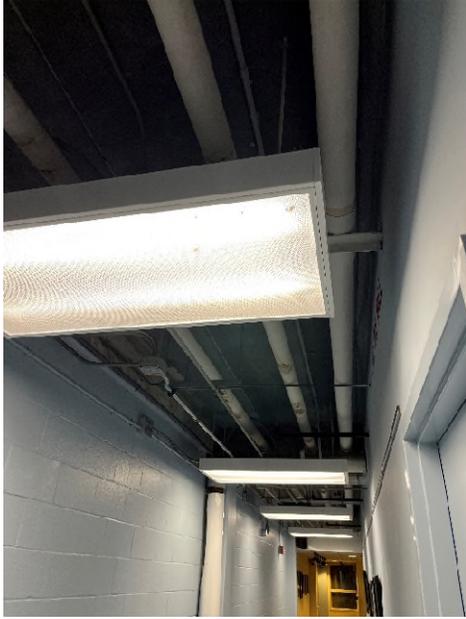
1/29/2024
			Photographer: Benjamin Best
5	Location / Material Description	Main Exhibit Building, East Wing / Fluorescent Light Fixture (Linear Bulb)	
	Remarks	Typical view of fluorescent light fixture ballast that may contain PCBs, and fluorescent light bulbs can contain mercury.

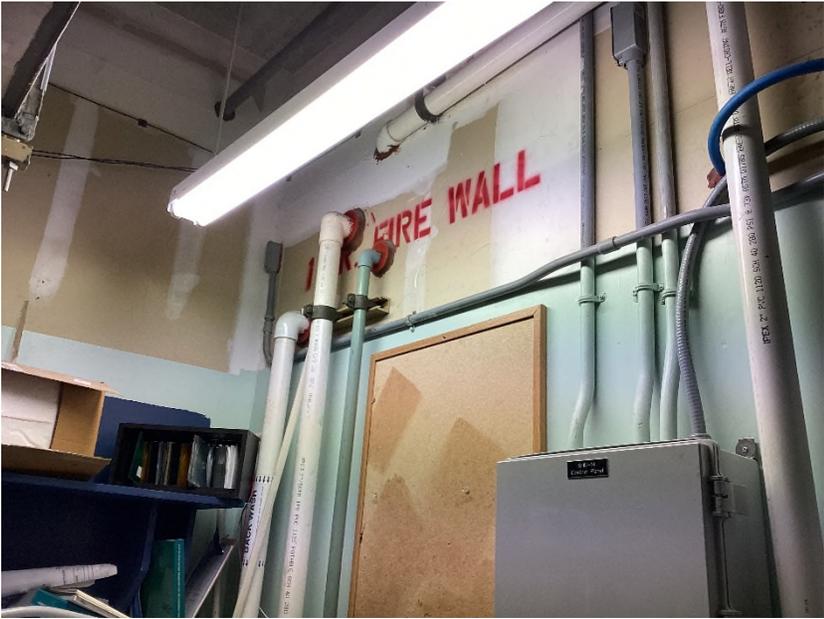
1/29/2024
			Photographer: Benjamin Best
6	Location / Material Description	Main Exhibit Building, East Wing / Fluorescent Light Fixture (Linear Bulb)	
	Remarks	Typical view of fluorescent light fixture ballast that may contain PCBs, and fluorescent light bulbs can contain mercury.

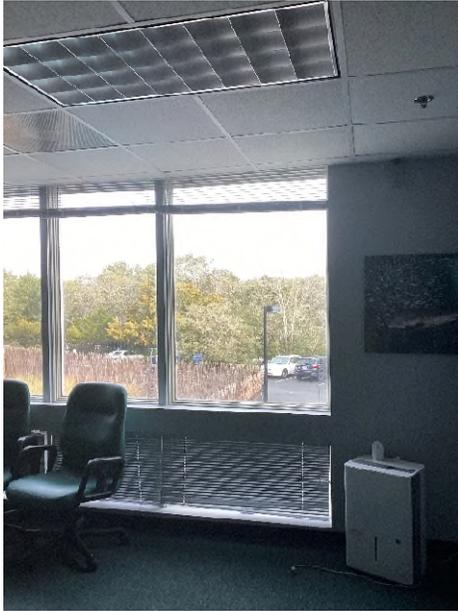
1/29/2024
			Photographer: Benjamin Best
9	Location / Material Description	Main Exhibit Building, East Wing / Fluorescent Light Fixture (U-shape Bulb)	
	Remarks	Typical view of fluorescent light fixture ballast that may contain PCBs, and fluorescent light bulbs can contain mercury.

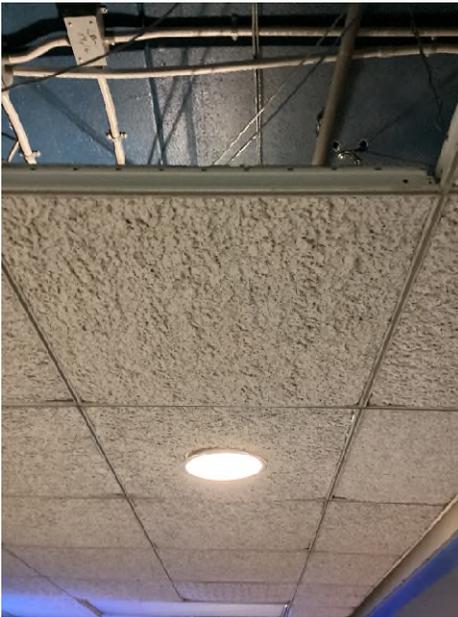
1/29/2024
			Photographer: Benjamin Best
10	Location / Material Description	Main Exhibit Building, East Wing / Fluorescent Light Fixture (U-shape Bulb)	
	Remarks	Typical view of fluorescent light fixture ballast that may contain PCBs, and fluorescent light bulbs can contain mercury.

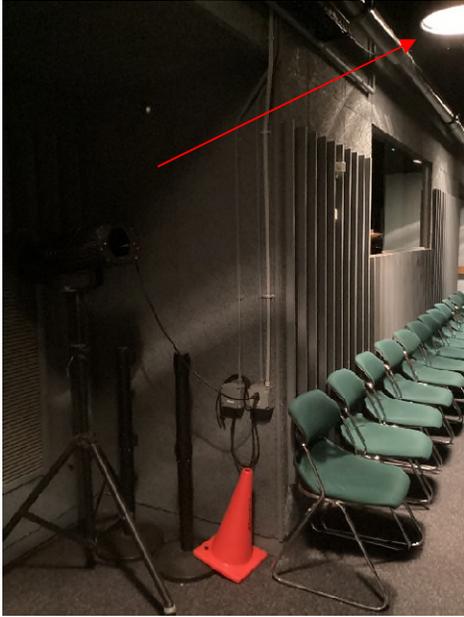
1/29/2024
			Photographer: Benjamin Best
11	Location / Material Description	Main Exhibit Building, East Wing (Auditorium)/ High Intensity Light Fixture	
	Remarks	Typical view of high intensity light fixture ballast that may contain PCBs, and fluorescent light bulbs can contain mercury.

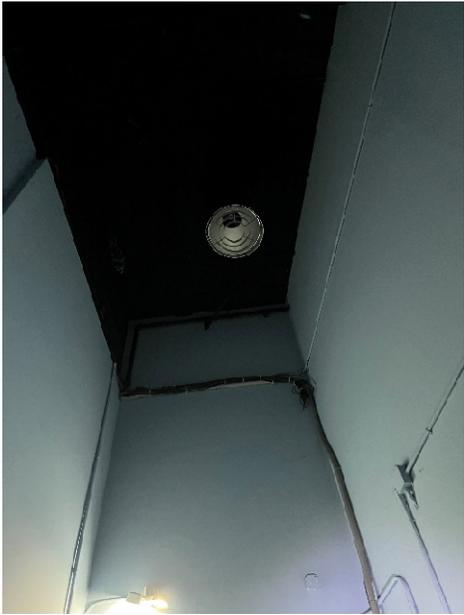
1/29/2024
			Photographer: Benjamin Best
12	Location / Material Description	Main Exhibit Building, East Wing (Auditorium/Exhibit Area)/ High Intensity Light Fixture	
	Remarks	Typical view of high intensity light fixture ballast that may contain PCBs, and fluorescent light bulbs can contain mercury.

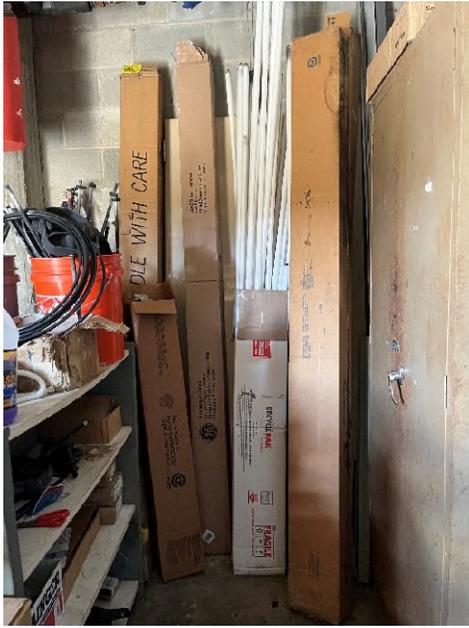
1/29/2024
				Photographer: Benjamin Best
13	Location / Material Description	Main Exhibit Building, East Wing (Boiler Room)/ Fluorescent Light Fixture (linear Bulb)		
	Remarks	Fluorescent light bulbs may contain mercury.

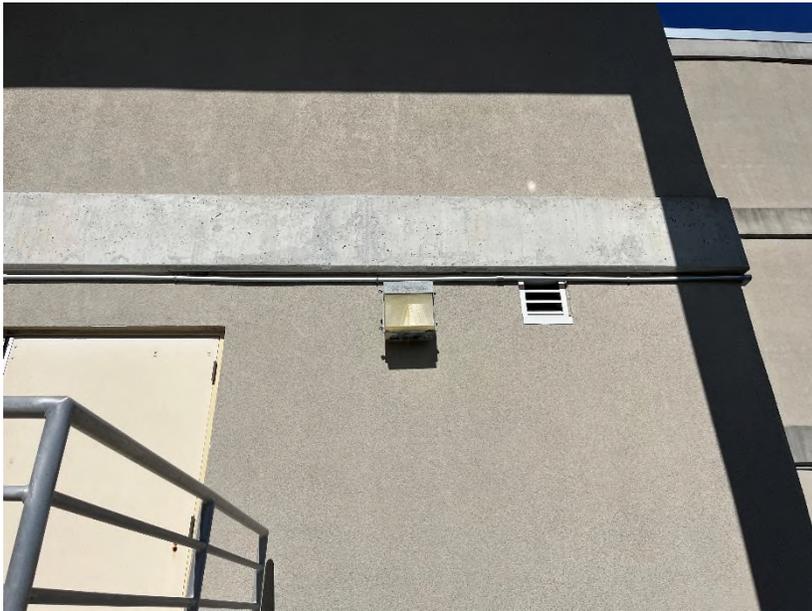
1/29/2024
				Photographer: Benjamin Best
14	Location / Material Description	Main Exhibit Building, East Wing / High Intensity Light Fixture		
	Remarks	Typical view of high intensity light fixture ballast that may contain PCBs, and fluorescent light bulbs can contain mercury.

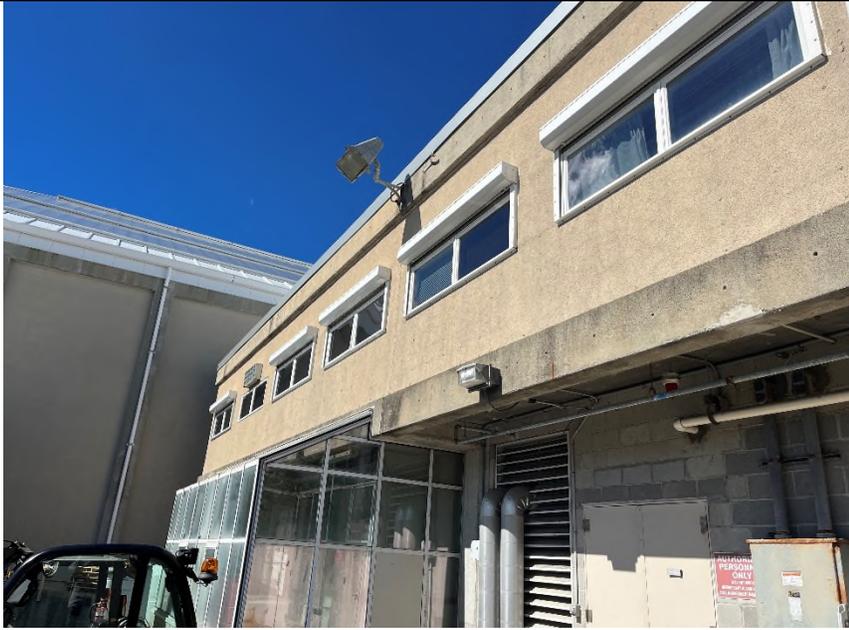
1/29/2024
				Photographer: Benjamin Best
15	Location / Material Description	Main Exhibit Building, East Wing / High Intensity Light Fixture		
	Remarks	Typical view of high intensity light fixture ballast that may contain PCBs, and fluorescent light bulbs can contain mercury.

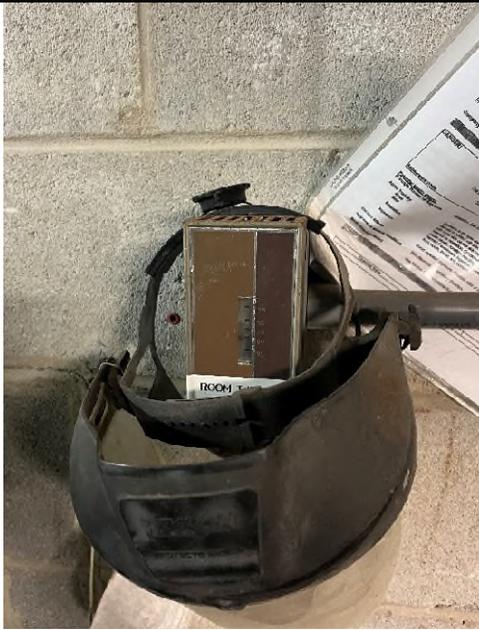
1/29/2024
				Photographer: Benjamin Best
16	Location / Material Description	Main Exhibit Building, East Wing / Thermostat		
	Remarks	Typical view of older thermostats that may contain mercury.

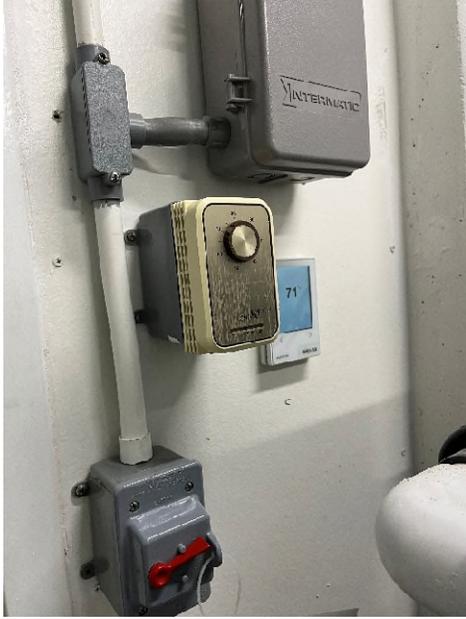
1/29/2024
				Photographer: Benjamin Best
17	Location / Material Description	Main Exhibit Building, East Wing / Thermostat		
	Remarks	Typical view of older thermostats that may contain mercury.

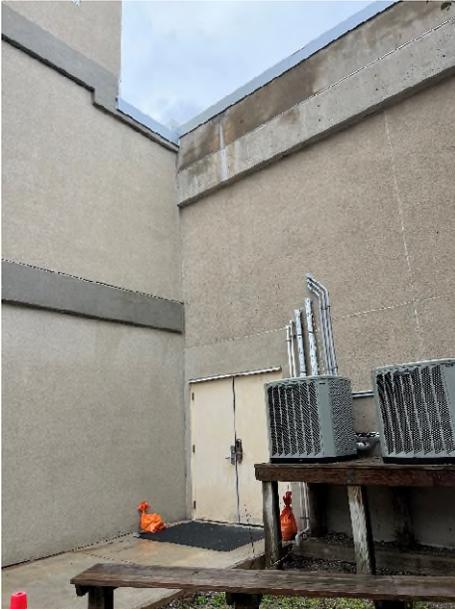
1/29/2024
				Photographer: Benjamin Best
18	Location / Material Description	Main Exhibit Building, East Wing / HVAC Compressors		
	Remarks	Typical view of cooling or refrigeration equipment that may contain chlorofluorocarbons (CFCs).

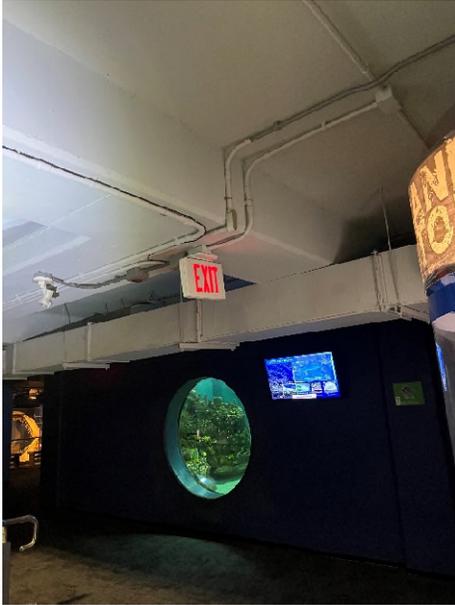
1/29/2024	Photographer: Benjamin Best
19	Location / Material Description	Main Exhibit Building, East Wing / Exit Signs	
	Remarks	Typical view of exit signs that may be connected to backup lead acid batteries.

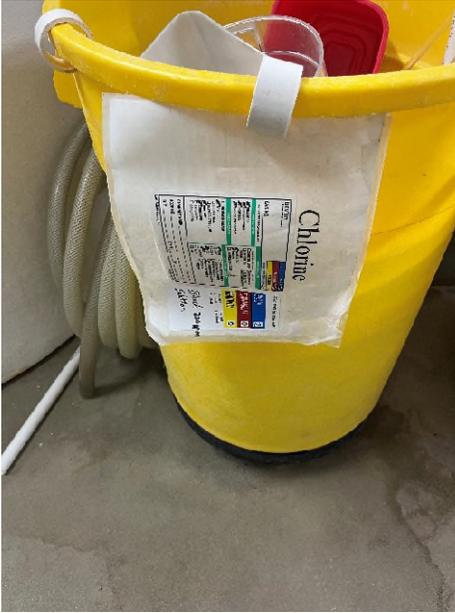
1/29/2024	Photographer: Benjamin Best
20	Location / Material Description	Main Exhibit Building, East Wing / Chlorine Solution	
	Remarks	Chlorine Solution was observed in Husbandry 231.

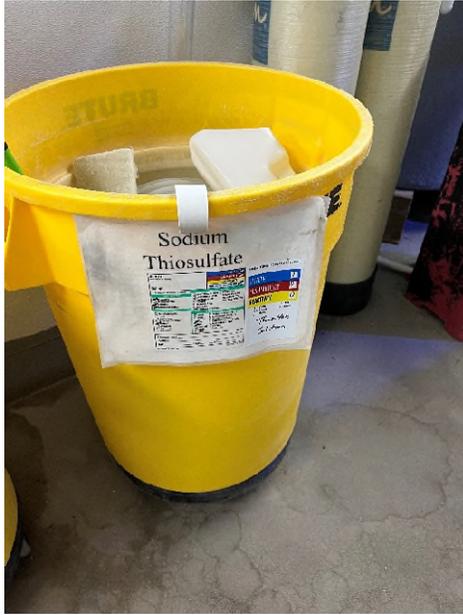
1/29/2024
			Photographer: Benjamin Best
21	Location / Material Description	Main Exhibit Building, East Wing / Sodium Thiosulfate Solution	
	Remarks	Sodium Thiosulfate Solution was observed in Husbandry 231.

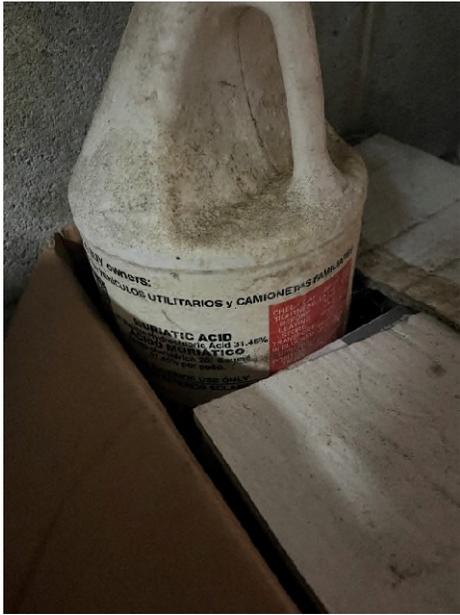
1/29/2024
			Photographer: Benjamin Best
22	Location / Material Description	Main Exhibit Building, East Wing / Muriatic Acid	
	Remarks	Muriatic Acid was observed in Mechanical Room 131.

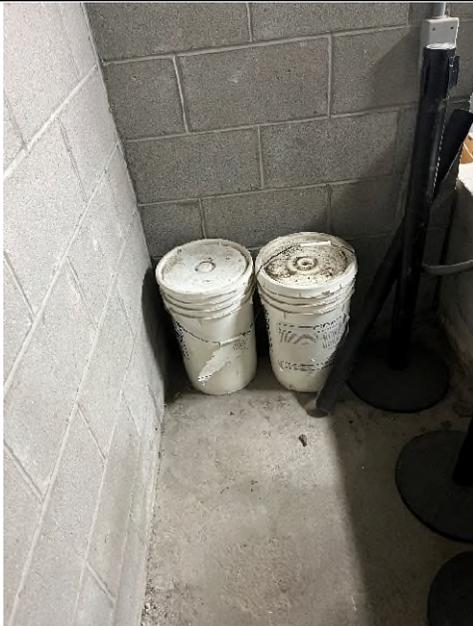
1/29/2024
				Photographer: Benjamin Best
23	Location / Material Description	Main Exhibit Building, East Wing / Citric Acid		
	Remarks	Citric Acid was observed in Mechanical Room 131.

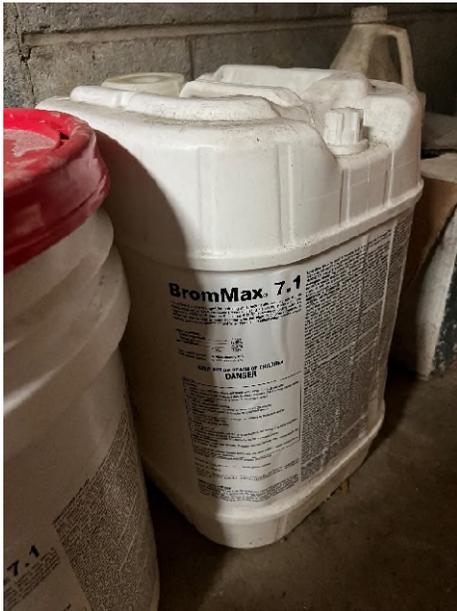
1/29/2024
				Photographer: Benjamin Best
24	Location / Material Description	Main Exhibit Building, East Wing / BromMax		
	Remarks	BromMax was observed in Mechanical Room 131.

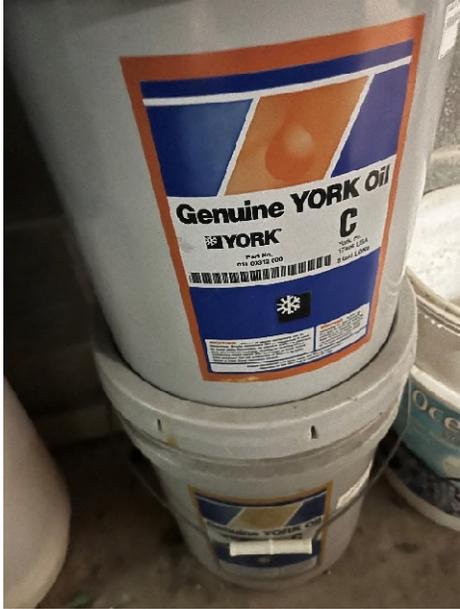
1/29/2024
				Photographer: Benjamin Best
25	Location / Material Description	Main Exhibit Building, East Wing / Motor Oil		
	Remarks	Motor oil was observed in Mechanical Room 131.

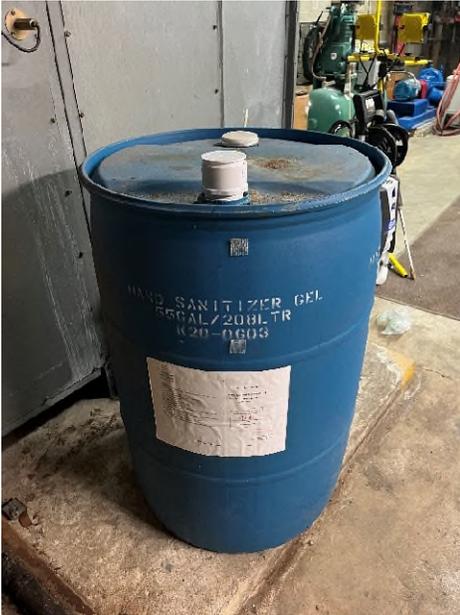
1/29/2024
				Photographer: Benjamin Best
26	Location / Material Description	Main Exhibit Building, East Wing / Hand Sanitizer		
	Remarks	Hand Sanitizer was observed in Mechanical Room 131.

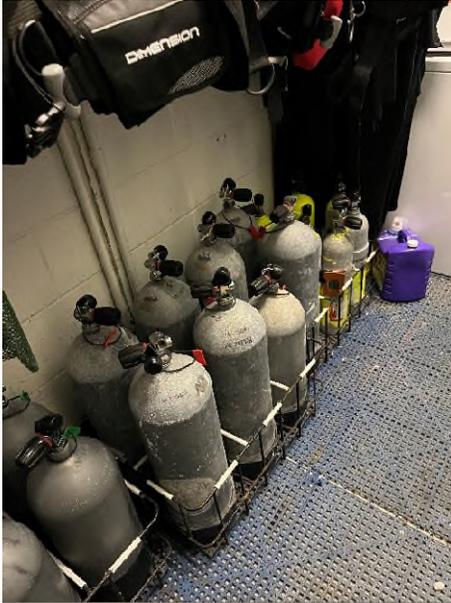
1/29/2024
			Photographer: Benjamin Best
27	Location / Material Description	Main Exhibit Building, East Wing / Compressed Air	
	Remarks	Oxygen tanks were observed in Room 305.

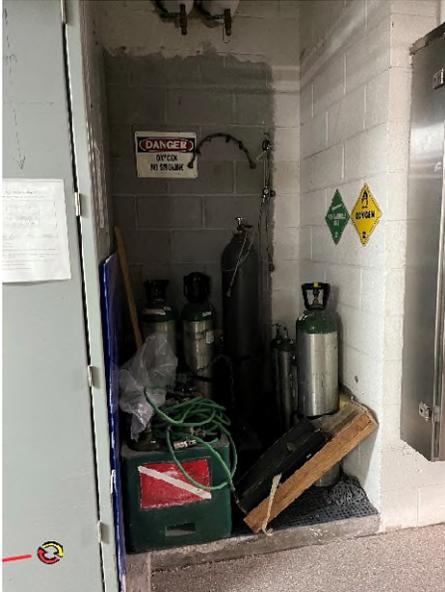
1/29/2024
			Photographer: Benjamin Best
28	Location / Material Description	Main Exhibit Building, East Wing / Compressed Air	
	Remarks	Oxygen tanks were observed in Husbandry 134.

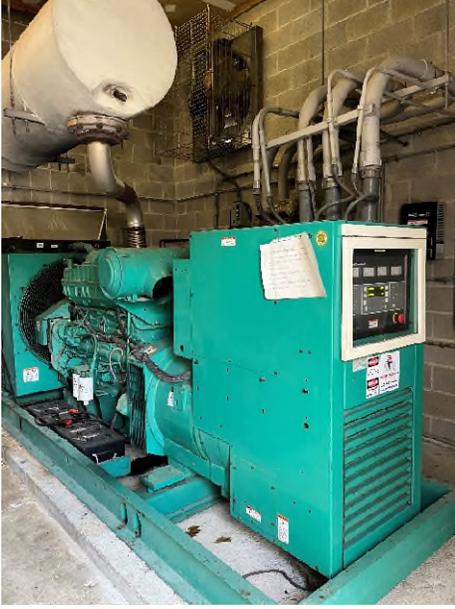
1/29/2024	Photographer: Benjamin Best
29	Location / Material Description	Generator Building / Generators	
	Remarks	Generators contain petroleum products such as diesel, coolant, and oil.

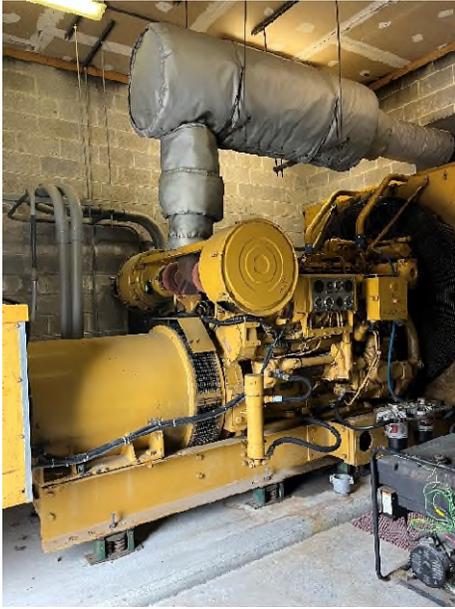
1/29/2024	Photographer: Benjamin Best
30	Location / Material Description	Generator Building / Generators	
	Remarks	Generators contain petroleum products such as diesel, coolant, and oil.

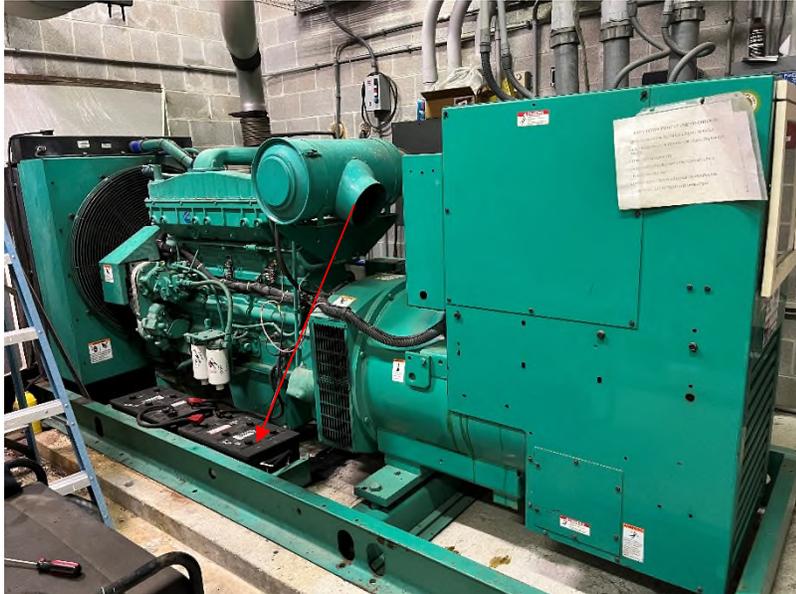
1/29/2024
		Photographer: Benjamin Best
31	Location / Material Description	Generator Building / Generators
	Remarks	Generators contain lead acid batteries.

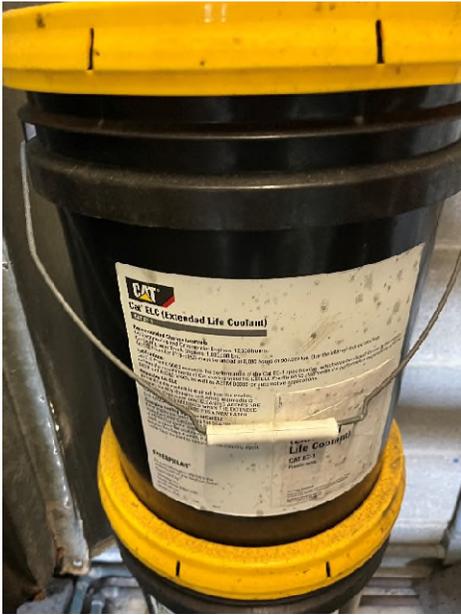
1/29/2024
		Photographer: Benjamin Best
32	Location / Material Description	Generator Building / Motor Coolant
	Remarks	Three 5-gallon containers of coolant were observed beside the generators.
