ADDENDUM NUMBER 1

Municipal Golf Course Club House Facility Additions & Renovations

Reference: Report of Asbestos Survey
Municipal Golf Course Clubhouse
311 Donald Ross Drive, North Carolina
ASE Project No. 1463

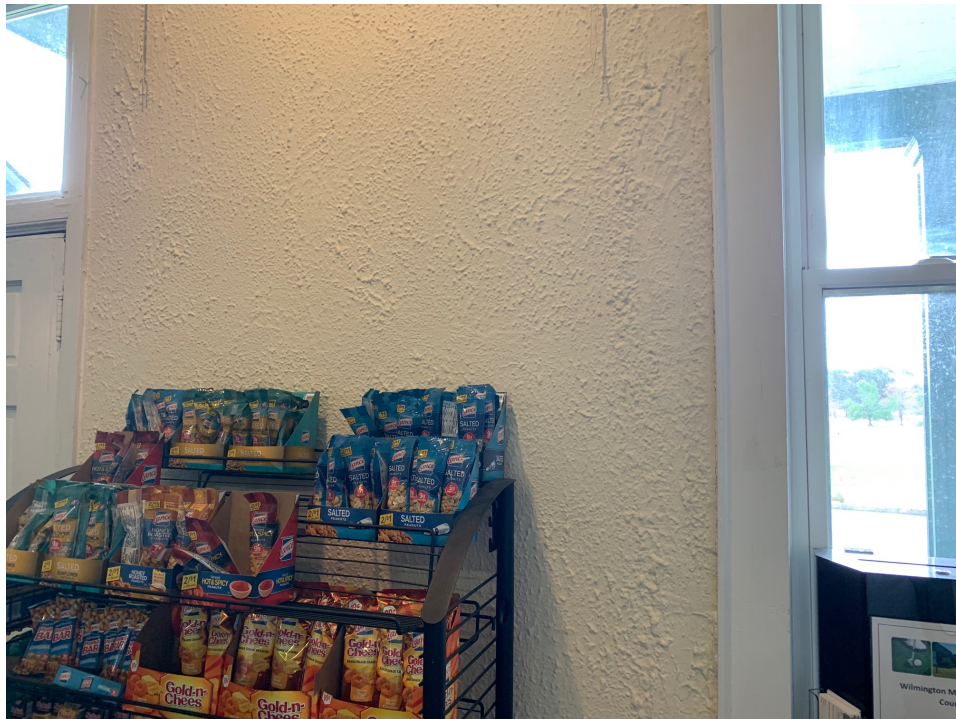
Photograph 1: Snack room wall surfacing (Samples: 9A, 9B and 9C)

It should be noted that the Occupational Safety and Health Administration (OSHA) regulates any quantity of asbestos material. This OSHA requirement is applicable to occupied buildings and deals with how to address asbestos to reduce occupational exposure to workers. OSHA regulations would require performing a negative exposure assessment (air monitoring on the first day of work to ensure that the material containing less than one percent is not an issue) and following OSHA worker protection rules during demolition and renovations. Material containing less than one percent asbestos includes the interior transom windows, interior wall surfacing on the snack room and exterior wall surfacing.

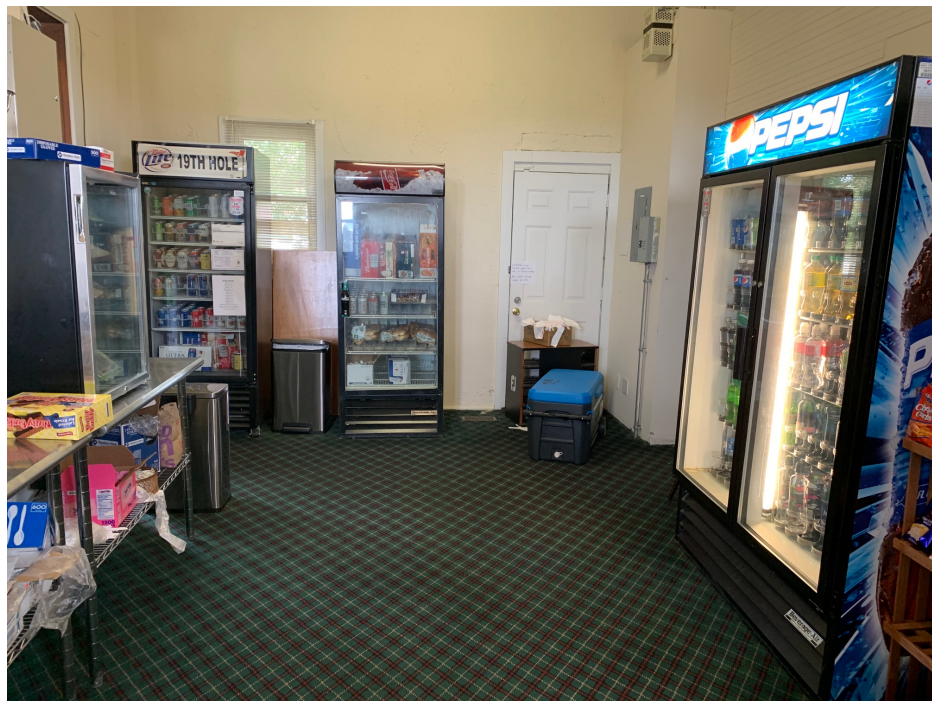
Photograph 2: Snack room wall surfacing (Samples: 9A, 9B and 9C)

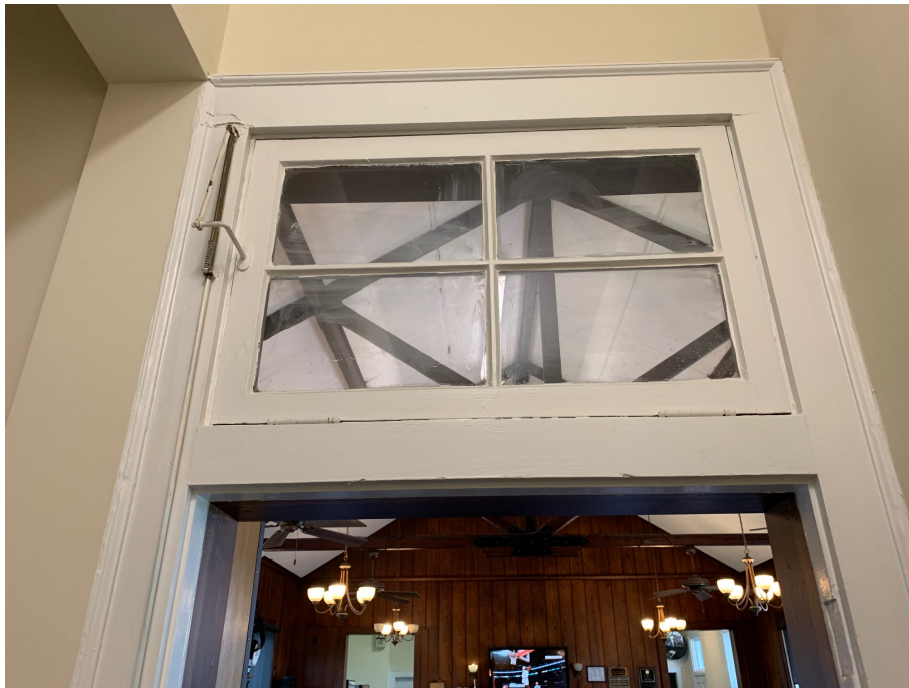
Photograph 3: Transom window glazing (Samples: 10A and 10B)

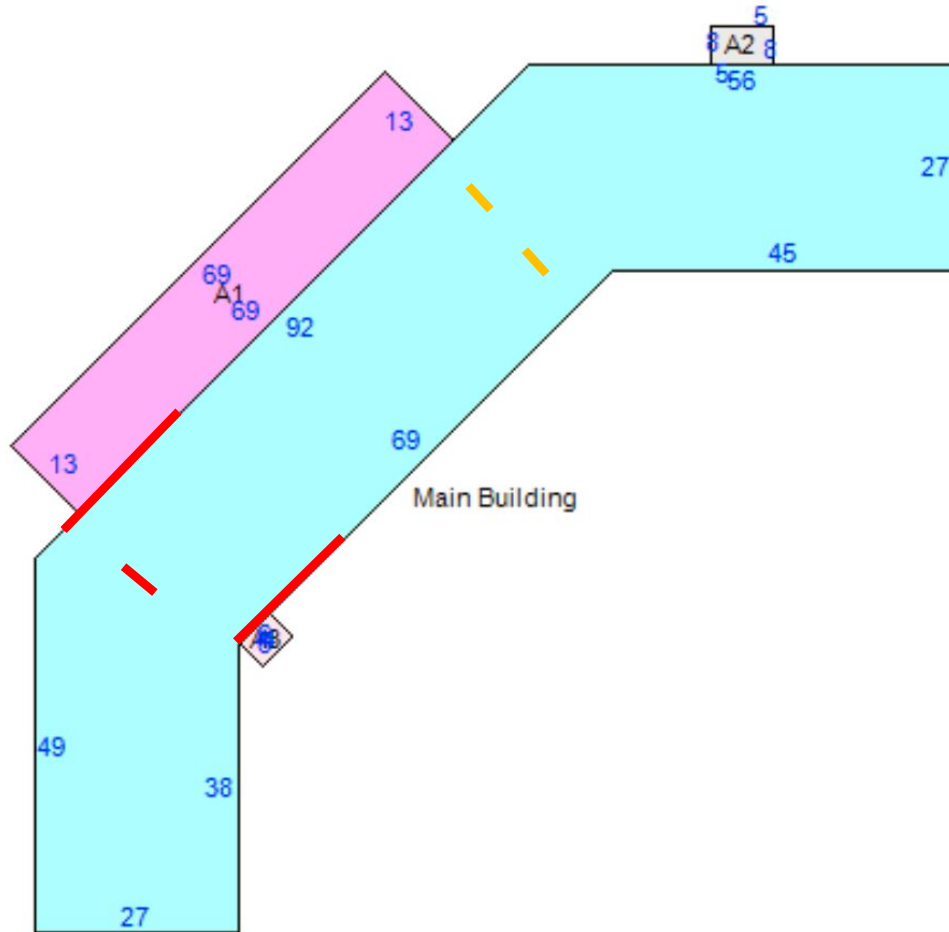
FIGURE 1: LOCATIONS OF MATERIALS CONTAINING <1% ASBESTOS

Key	
—	Samples 9A, 9B and 9C
—	Samples 10A and 10B
All Exterior Surfacing contain <1% Asbestos
