CLARIFICATION NO. 4

North Carolina Aquariums at Fort Fisher Expansion + Renovation

FORT FISHER AQUARIUM EXPANSION PROJECT – HAZARDOUS MATERIALS REVIEW

Reference: **Limited Hazardous Materials Assessment Report**
NC Aquarium Fort Fisher Addition and Renovation
Kure Beach, North Carolina
S&ME Project No. 23060119

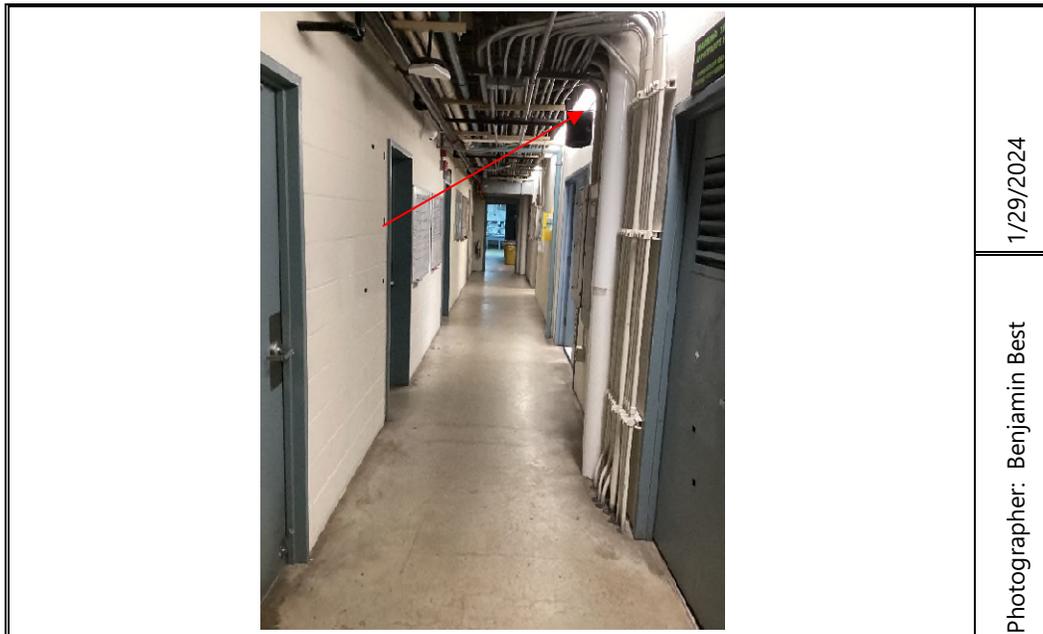
1/29/2024
			Photographer: Benjamin Best
6	Location / Material Description	Main Exhibit Building, East Wing / Fluorescent Light Fixture (Linear Bulb)	
	Remarks	Typical view of fluorescent light fixture ballast that may contain PCBs, and fluorescent light bulbs can contain mercury.

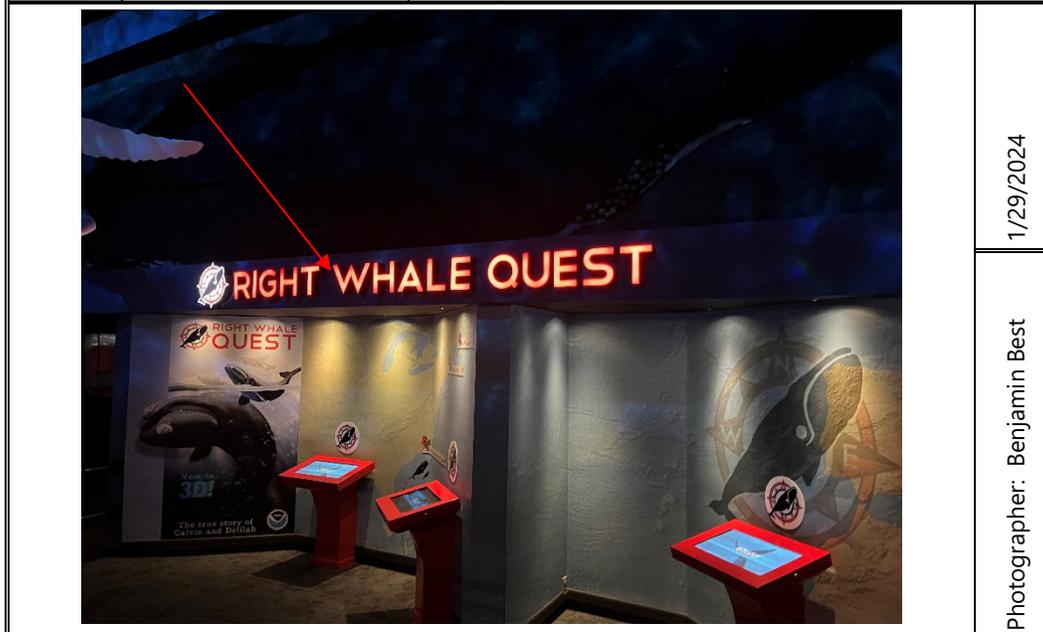
7	Location / Material Description	Main Exhibit Building, East Wing / Fluorescent Light Fixture (Linear Bulb)
	Remarks	Typical view of fluorescent light fixture ballast that may contain PCBs, and fluorescent light bulbs can contain mercury.
